Elite Home Inspections

127 E ANYWHERE DRIVE, SOMEWHERE, NC 12345

Inspection prepared for: REPORT SAMPLE

Date of Inspection: 1/1/2021 Time: 9:00 AM

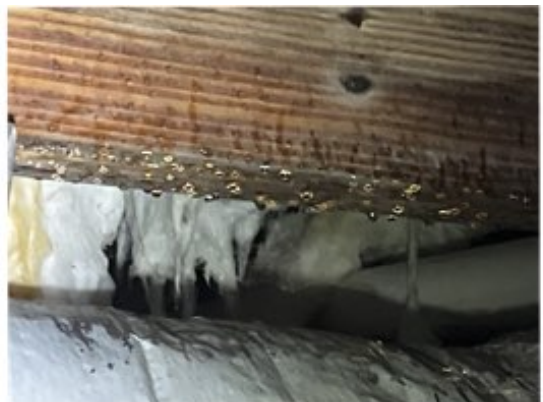
2.6. The insulation system in the crawl space is falling down and/or streaming/delaminating. This condition is typical of high moisture and/or pest infiltration or both and reduces the effective value of the insulation.

STREAMING INSULATION, SATURATED

Recommendation: Insulation Contractor, Moisture & Pest Contractor

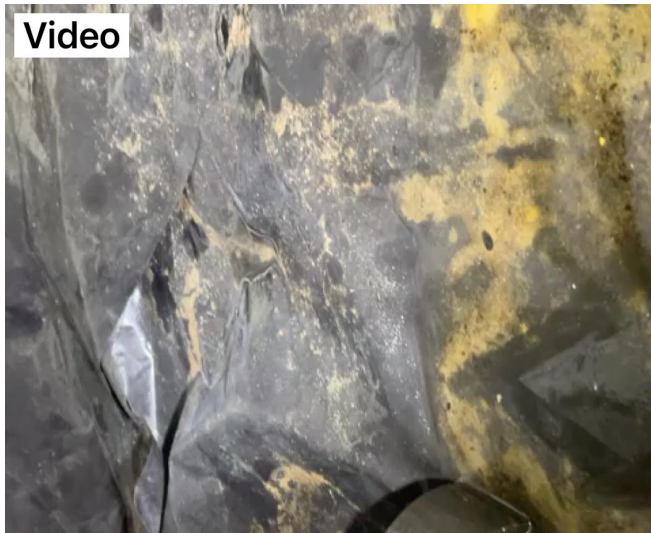
2.5. During our inspection of the crawlspace evidence of historical high moisture content is present on numerous darkened floor joists and/or wood structural components. This condition indicates a history of excessive moisture (abnormal water penetration and/or abnormal condensation).

Probing reveals deterioration to the framing components in the floor system.

PROBING REVEALS DETERIORATION IN AREAS

Further evaluation is recommended and/or required to determine the extent "scope" of the discovery. Corrective work is recommended to prevent further deterioration (damage) of the wood framing components (system), and to address the moisture issues.

Recommendation: Licensed General Contractor

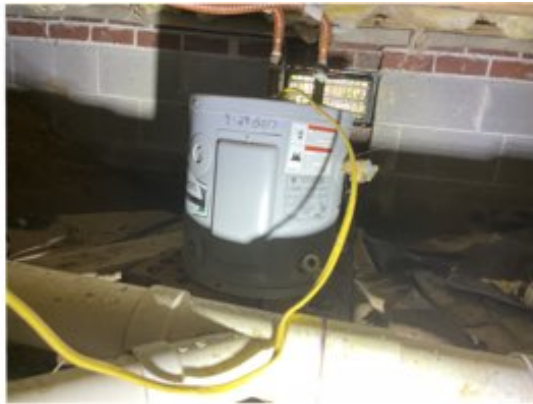
4.1. The water heater is located in the crawl space. This location is subject to high humidity, possible water intrusion as well as unconditioned space. The unit is sitting in damp conditions with no approved dedicated stand
We recommend a licensed plumber further evaluate this installation and determine if the location is an approved location by the appliance manufacturer and local code requirements.
Due to location our concern is electrical components in high humidity environment causing corrosion, possibly flooding causing multiple problems and freeze/thaw etc.....
Have this evaluated by a licensed plumber and confirm if the appliance is approved for this location and or make corrections.

WATER HEATER IN CRAWL

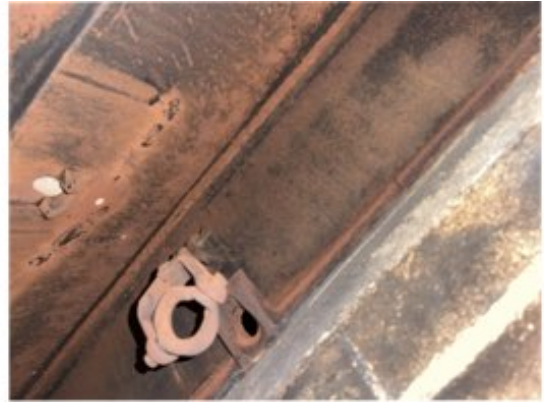
DAMPER NOT FUNCTIONAL

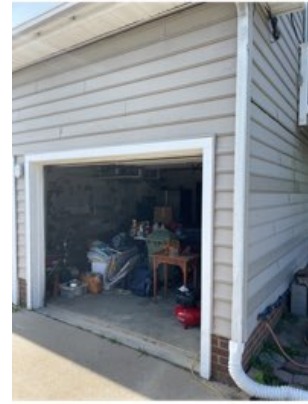
DAMAGED TRIM, LOWER GARAGE DOORS

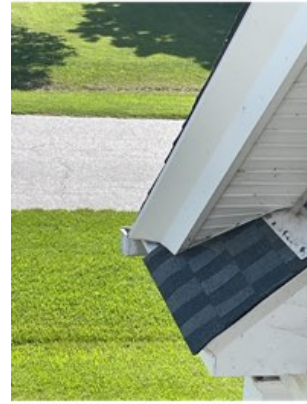
LOOSE TRIM

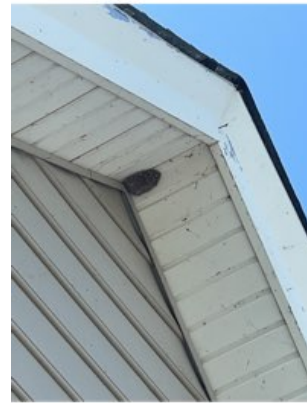
1.6. The **PVC coated metal wrap used to cover the sub fascia's, rakes and associated trim systems has areas where the protective PVC surface treatment/ coating has adhesive failure.**

The loss of the PVC coating suggests a manufacturers defect and can allow for pre mature deterioration from weather / corrosion which can lead to damage to the metal wrap which can eventually allow enough deterioration for water intrusion.

PVC ADHESIVE FAILURE

recommend a general contractor further evaluate this discovery and makes corrections/ replace the affected areas before this occurs.

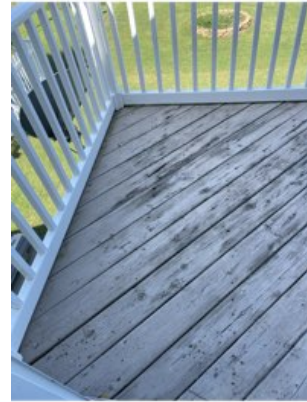
2.4. Safety issue noted due to inadequate railing attachment.

LOOSE RAILINGS

Second floor office balcony and back elevated deck safety concern, general contractor recommended.

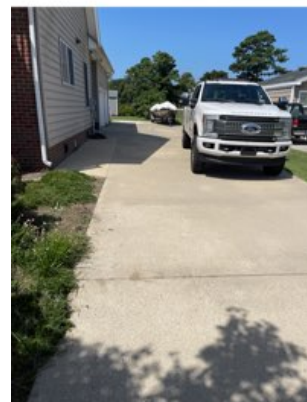
FRONT WALK TRIP HAZARD

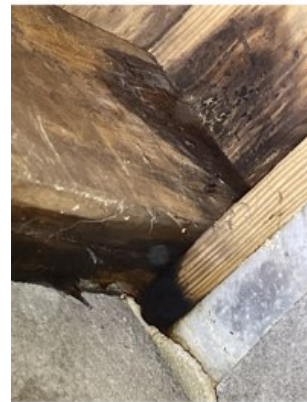
CHIMNEY FRAMING MOISTURE INFILTRATION

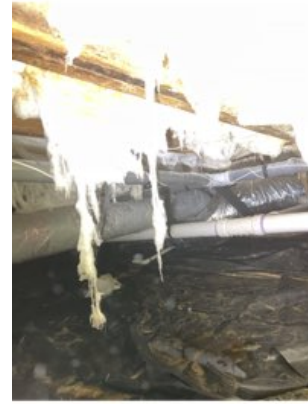
STREAMING INSULATION, SATURATED

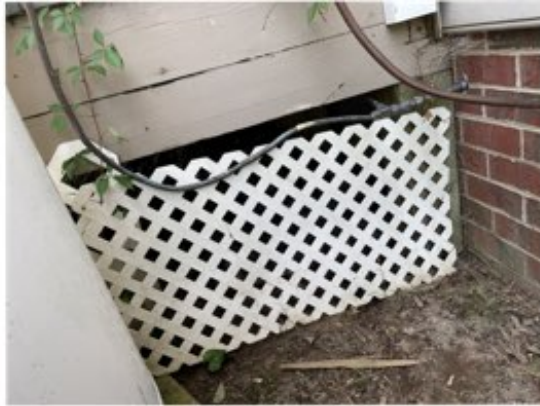
PROBING REVEALS DETERIORATION IN AREAS

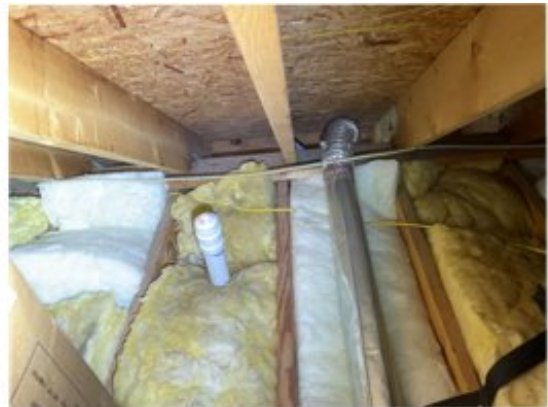
STAINS DRY, BACK KNEE WALL

Recommendation:Roofing Contractor

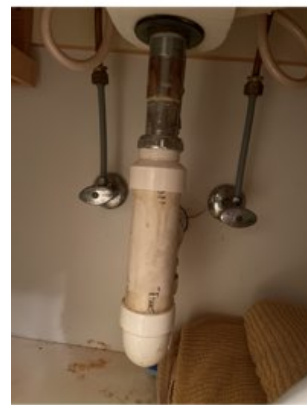
2.2. There is a leaking faucet handle/s located in the second floor back bath sink that need correction. The leaks are observed during the function/operation of the faucets. Without corrections the leaks can infiltrate into the sink base and cause water damage. Have a licensed plumber evaluate and make corrections

SECOND FLOOR BACK BATHROOM SINK RIGHT
SIDE VALVE LEAKS

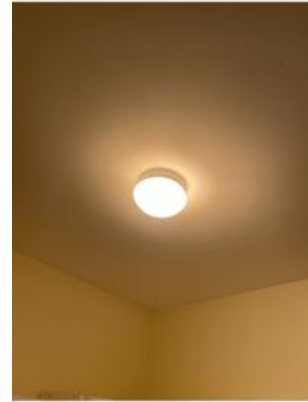
5.2. There is/ are light fixtures located in the master closet, second floor bedroom balcony exterior door, back second floor slider deck light that when tested do not function/ illuminate. There may be a visible bulb installed, there may not be. In many cases the new low voltage bulbs do not respond to a voltage tester. Therefore we believe that the named fixtures should be further evaluated, bulbs installed, replaced and or further evaluated by an electrician to determine the cause for no illumination.

MASTER CLOSET LIGHT OUT

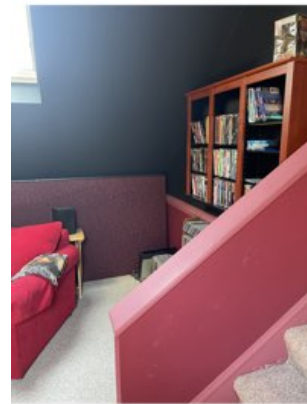
HANDLE MISSING

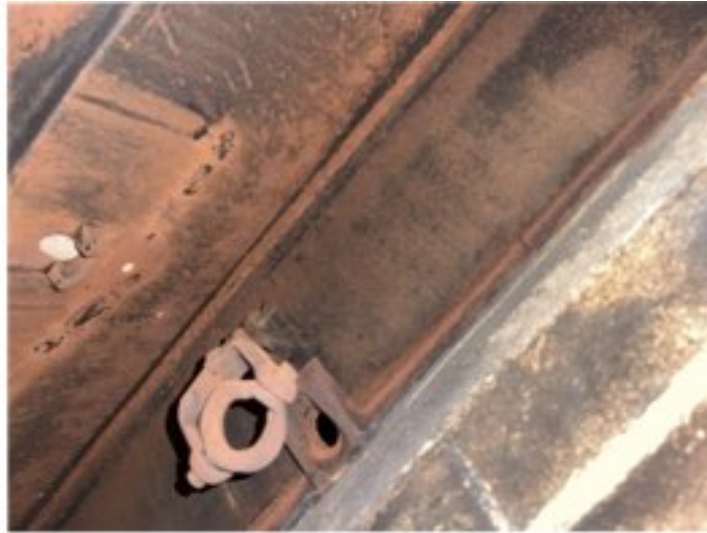
3.1. The main Gas Logs where found sooted. Heavy soot suggesting improper combustion as well as dust and lint where found covering the logs , burner and associated components. Have a gas log technician or a gas contractor further evaluate the instalation and clean the appliance and test for safety and operate to ensure function. without corrections the gas logs may off gas harmful fumes

DAMPER NOT FUNCTIONAL
