Elite Home Inspections

127 E ANYWHERE DRIVE, SOMEWHERE, NC 12345

Inspection prepared for: REPORT SAMPLE

Date of Inspection: 1/1/2021 Time: 9:00 AM

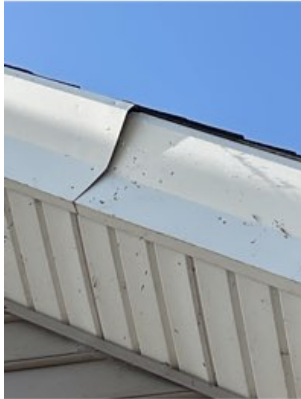
LOOSE RAKE TRIM, RIGHT SIDE

invasive measures, decay can exist that should be repaired
It is recommended that a siding contractor further evaluate the exterior trim work by removing areas suspect and make adjustments, repairs and corrections to secure the exterior of the home remains weather tight.

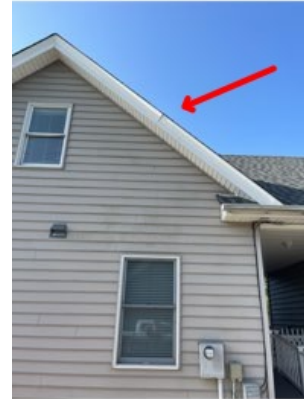
TRIM

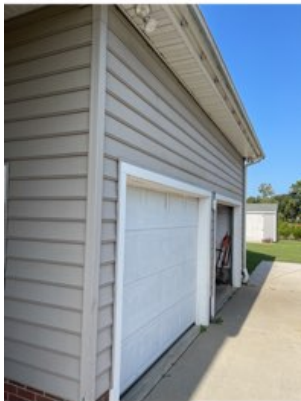
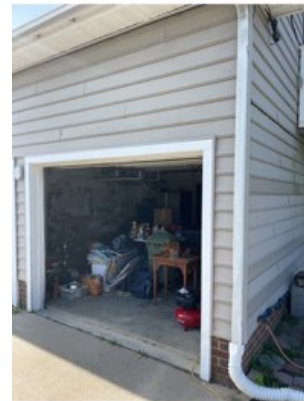
DAMAGED TRIM, LOWER GARAGE DOORS

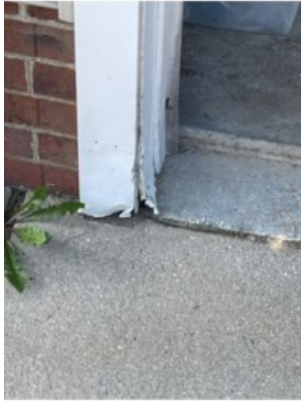
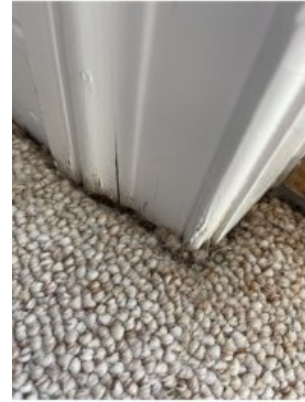
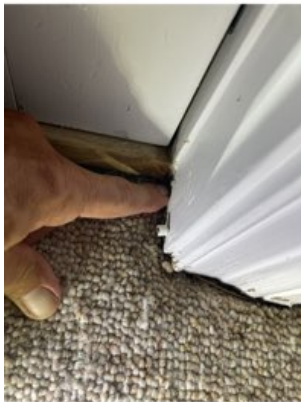
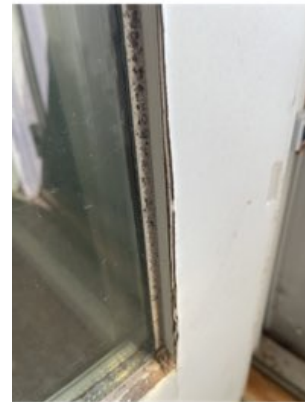
1.8. The exterior entry doors located at the second floor office, left, second floor bedroom, right, second floor back movie room slider, back of garage at storage room, side garage are delaminating. Repair and/or replace to secure that the door operates, locks and seals.

The delamination allows moisture intrusion that leads to decay

SECOND FLOOR OFFICE/ LEFT DOOR, SOFT
INTERIOR JAMB
PULL CARPET BACK TO DETERMINE SCOPE

SECOND FLOOR OFFICE DOOR
DELAMINATION

A window/ door installer is recommended to evaluate all doors to determine repairs, replacement and life expectancy of all doors and windows

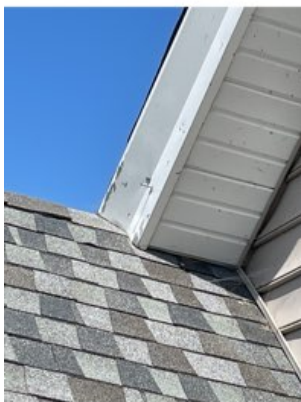
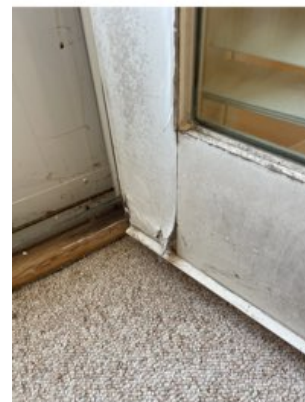
LOOSE TRIM
LEFT SIDE RAKES

SECOND FLOOR BEDROOM DOOR TO
BALCONY

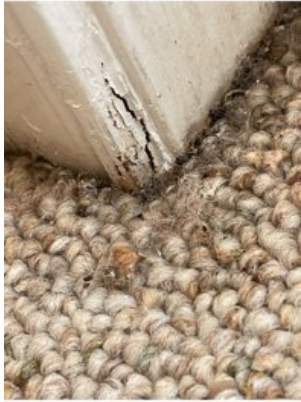
SECOND FLOOR BEDROOM DOOR TO
BALCONY

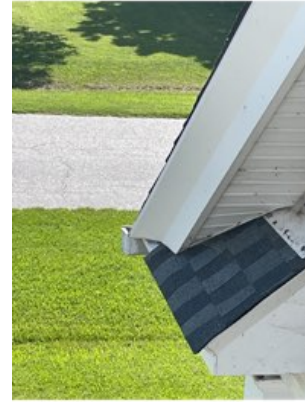
LOOSE TRIM

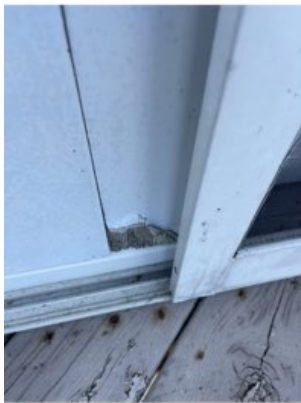
BACK SLIDER
DECK BALCONY

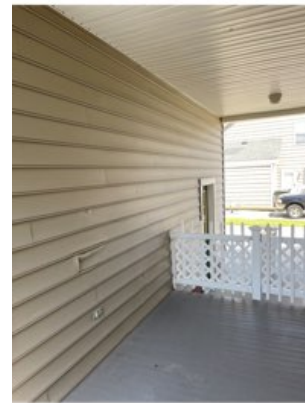
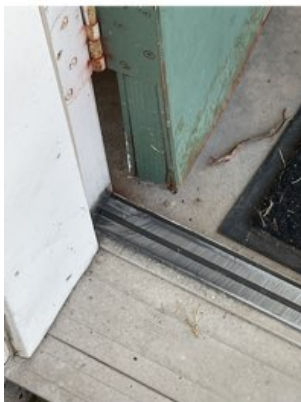
GARAGE SIDE ENTRY DOOR

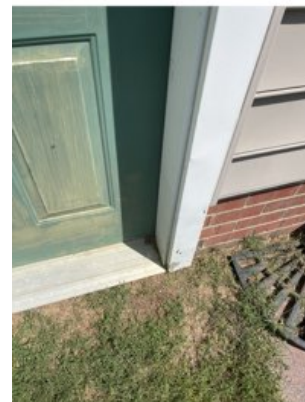
BACK SHED DOOR

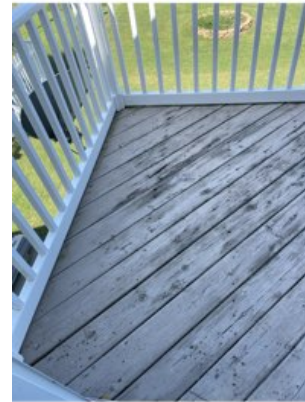
2.5. : The deck (both back deck and elevated back deck (2 decks) inspection reveals obsolete structural connections, deterioration, decay, stair and railing deficiencies. This is a safety concern The deck surfaces and associated components should be further evaluated by a general contractor to determine the remaining life expectancy of the current deck and the scope of the repairs required to ensure the deck is current and safe. Without corrections further deterioration can occur. This is a safety concern

BACK ELEVATED DECK

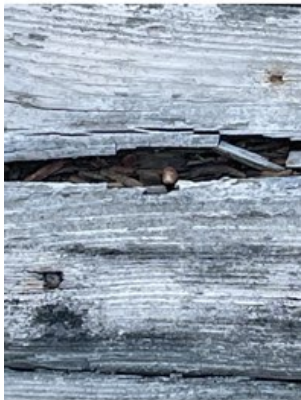
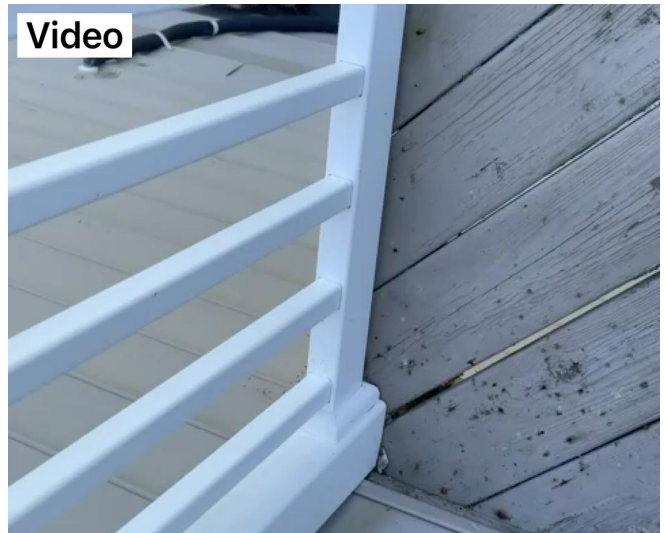
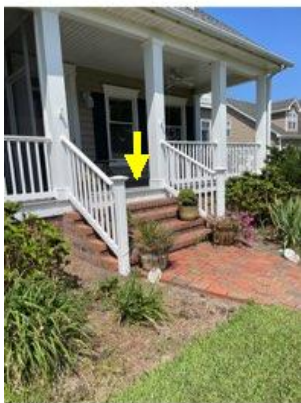
2.6. There is water damaged wood decking at the porch floor/decking surfaces, front at entry area and back at chimney. The water damage is the result of exposure and end grain wicking. Without corrections further deterioration will occur and may cause the decking to become unstable and a safety hazard. Wet water damaged wood is also an invitation for wood destroying insects. Replacement of affected deck components is recommended.

PORCH DECKING AGING

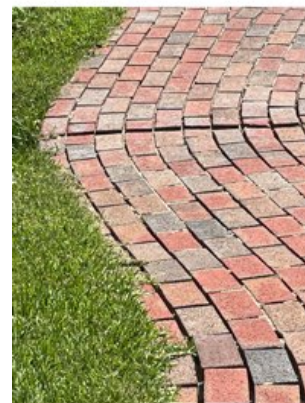
FRONT WALK TRIP HAZARD

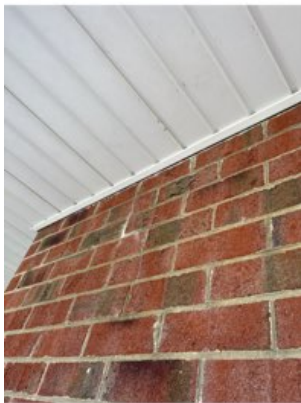
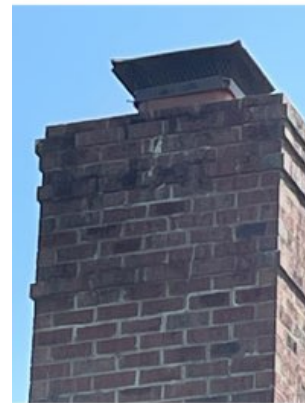
4.1. The mortar cap of this chimney, sometimes known as the 'crown', was found to be cracked, weather worn or damaged by exposure to weather, time and the corrosive effects of moss. When this occurs, water seeping past the crack can cause substantial damage to the masonry stack, as well as to the framing, walls and ceilings below. Having this stack and cap further evaluated/ repaired by a chimney mason or certified sweep is recommended. without corrections further water penetration can occur and lead to further deterioration of the fire box, chimney and any associated components in contact with the chimney

VEGETATION / MOSS GROWTH CHIMNEY

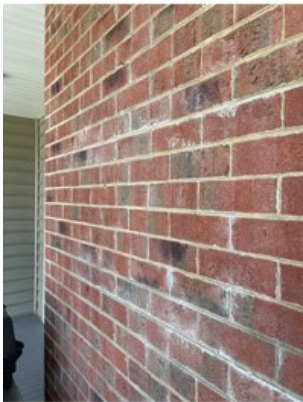
2.11. Efflorescence was visible on the masonry chimney wall. This is a indication of historical water intrusion or a water source and path that can lead to structural deterioration and damage. It is recommended that this

CHIMNEY EFFLORVESENCE

discovery be further evaluated by a general contractor to determine the source, affect or condition of the CMU foundation wall below the chimney, the chimney, the framing around the chimney and associated wall cavities and corrective measures. Without corrections this condition can lead to further deterioration and movement SEE REPORT BODY FOR INFORMATION ON THIS

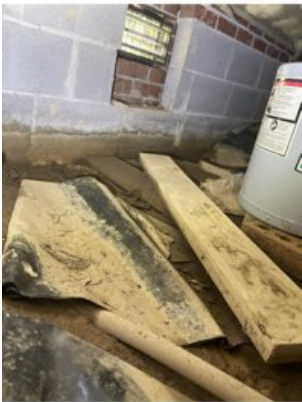
DEBRIS

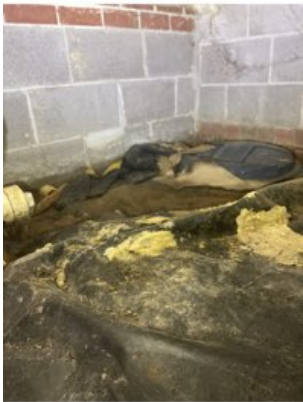
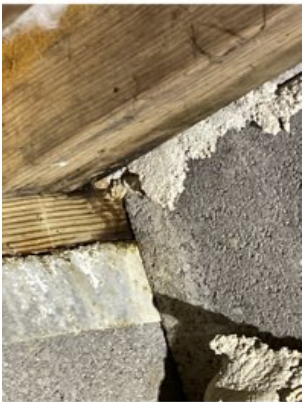
2.7. During our inspection of the crawlspace evidence of historical high moisture content is present around the framing of the fire place floor penetration structural components..

This discovery also suggests the chimney may be a catalyst for the moisture intrusion in and around the masonry system in the form of efflorescence and decay to the wood floor at the exterior where the chimney is in contact with the decking.

CHIMNEY FRAMING MOISTURE INFILTRATION

Repairs to the deteriorated framing and corrective work is recommended to prevent further deterioration (damage) of the wood framing components (system), and to address the cause of the moisture issues.

A general contractor is recommended.

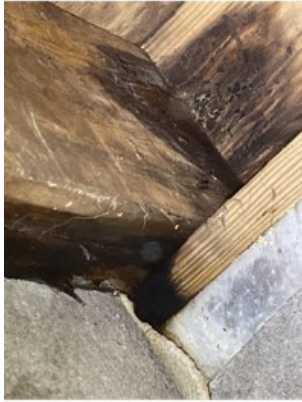
CHIMNEY AREA

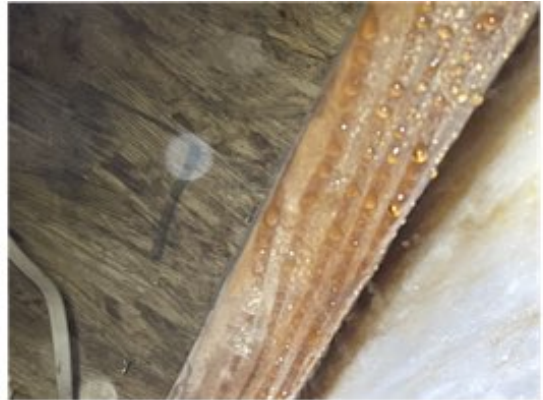
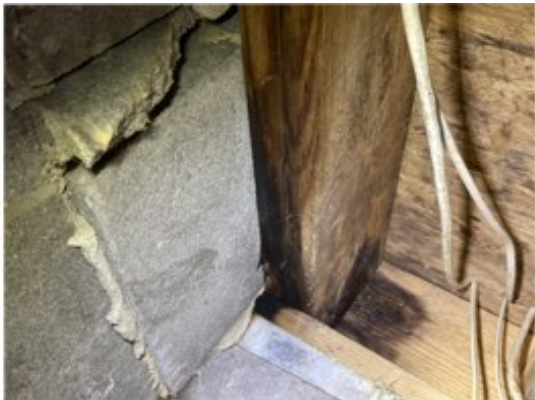
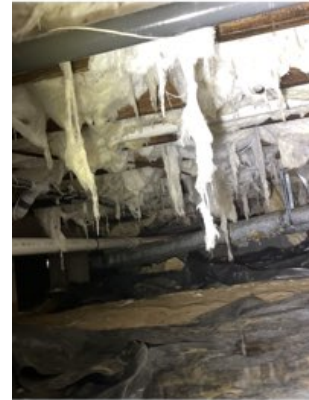
2.6. The insulation system in the crawl space is falling down and/or streaming/delaminating. This condition is typical of high moisture and/or pest infiltration or both and reduces the effective value of the insulation.

STREAMING INSULATION, SATURATED

Recommendation: Insulation Contractor, Moisture & Pest Contractor

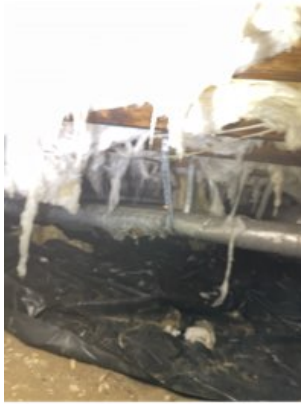
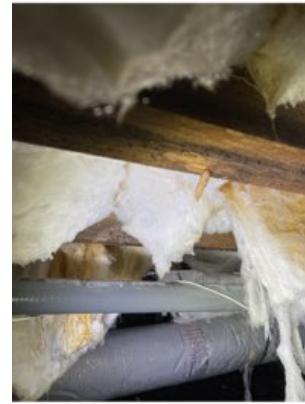
2.5. During our inspection of the crawlspace evidence of historical high moisture content is present on numerous darkened floor joists and/or wood structural components. This condition indicates a history of excessive moisture (abnormal water penetration and/or abnormal condensation).

Probing reveals deterioration to the framing components in the floor system.

PROBING REVEALS DETERIORATION IN AREAS

Further evaluation is recommended and/or required to determine the extent "scope" of the discovery. Corrective work is recommended to prevent further deterioration (damage) of the wood framing components (system), and to address the moisture issues.

Recommendation: Licensed General Contractor

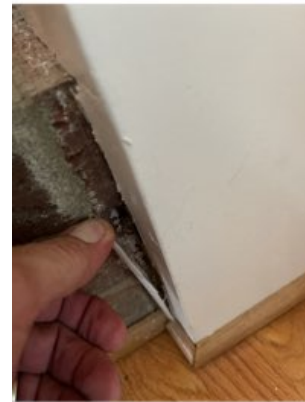
INTERIOR AROUND CHIMNEY

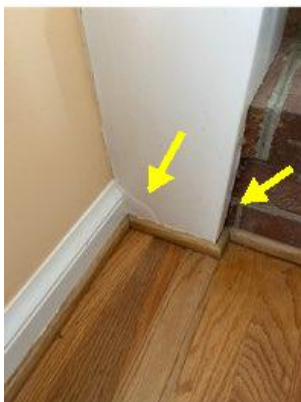
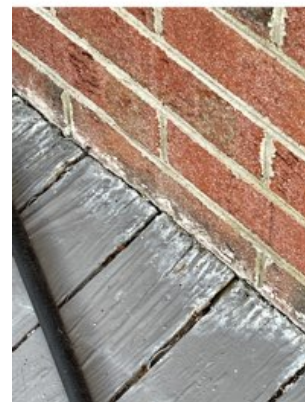
EXTERIOR PORCH AT MASINRY CHIMNEY WALL

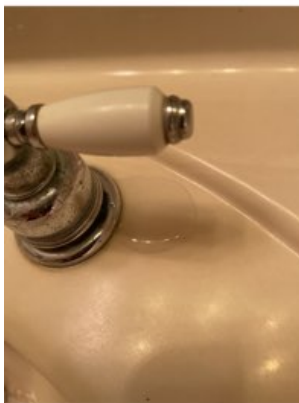
2.2. There is a leaking faucet handle/s located in the second floor back bath sink that need correction. The leaks are observed during the function/operation of the faucets. Without corrections the leaks can infiltrate into the sink base and cause water damage. Have a licensed plumber evaluate and make corrections

SECOND FLOOR BACK BATHROOM SINK
RIGHT SIDE VALVE LEAKS

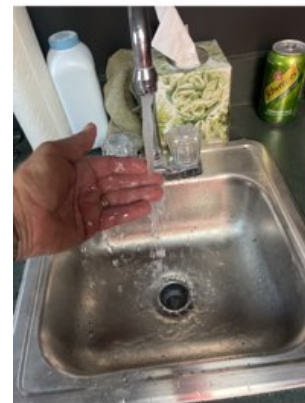
BAR SINK, HOT WATER ONLY, RIGHT SIDE NO
FLOW

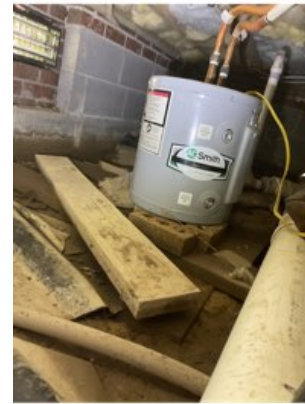
4.1. The water heater is located in the crawl space. This location is subject to high humidity, possible water intrusion as well as unconditioned space. The unit is sitting in damp conditions with no approved dedicated stand
We recommend a licensed plumber further evaluate this installation and determine if the location is an approved location by the appliance manufacturer and local code requirements.
Due to location our concern is electrical components in high humidity environment causing corrosion, possibly flooding causing multiple problems and freeze/thaw etc.....
Have this evaluated by a licensed plumber and confirm if the appliance is approved for this location and or make corrections.

WATER HEATER IN CRAWL

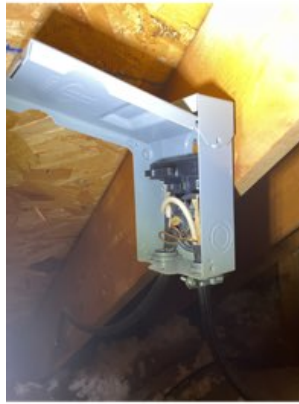
2.1. : The service disconnect that is missing the protective cover that isolates the electrical conductors and lugs from contact.
The subject disconnect box is missing this interior cover and is therefore a contact hazard and potentially can cause harm if contact is made. As well as is exposed to the weather which can lead to corrosion and or pest damage
Have an electrician evaluate and make corrections by installing the correct cover intended for this disconnect box.
Recommendation: Licensed Electrician
Location: Attic

ATTIC HVAC DISCONNECT MISSING COVER

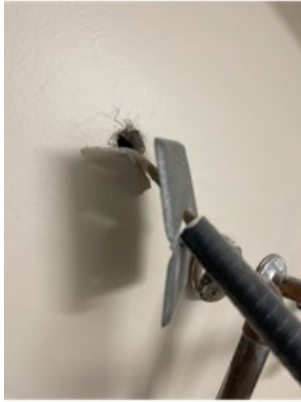
3.2. : There is wiring entering the wall at the water heater service that is short in conduit coverage and that does not have approved strain relief bushings. Wiring that enters the any enclosure, box or cabinet is supposed to be solidly anchored and protected where it enters the enclosure/ device by a bushing so the sharp edges of the enclosure/ box does not cut into the wiring and cause a short which is a safety hazard. We recommend having a licensed electrician correct all un-bushed cables described.

WATER HEATER SERVICE, LUANDRY ROOM
WALL

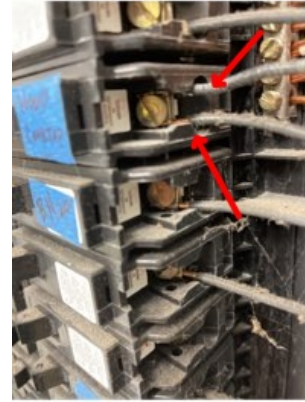
3.1. Double lugged breaker/s inside the service entrance panel was discovered. ONE, right side, pictured. Double lugging is where more than one branch circuit is connected to a single circuit breaker. Most breakers are not designed to accommodate more than one circuit. A licensed electrician should further evaluate this discovery to determine if this application is approved and it's combined load meets the circuit requirements. Without corrections the physical connection of the subject breaker is compromised which can lead to excessive heat and breaker damage. This is a safety discovery, therefore evaluation and correction by a licensed electrician is strongly recommended.

DOUBLE TAP ON BREAKER MARKED HOOD
COOK TOP

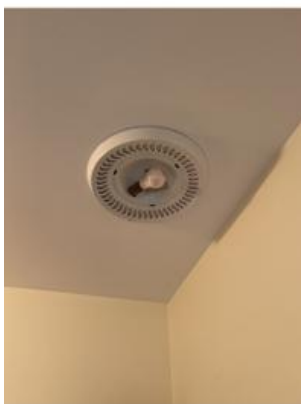
5.2. There is/ are light fixtures located in the master closet, second floor bedroom balcony exterior door, back second floor slider deck light that when tested do not function/ illuminate. There may be a visible bulb installed, there may not be. In many cases the new low voltage bulbs do not respond to a voltage tester. Therefore we believe that the named fixtures should be further evaluated, bulbs installed, replaced and or further evaluated by an electrician to determine the cause for no illumination.

MASTER CLOSET LIGHT OUT

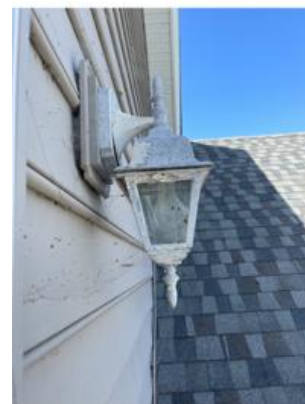
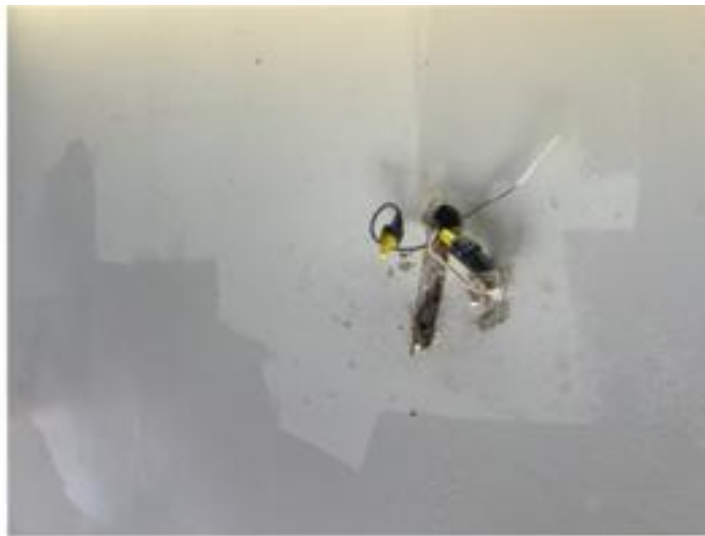
GARAGE CEILING

5.3. There are one or more/ multiple electrical ceiling light / light fan fixtures that have been removed and the conductors are exposed and live if switched. This discovery is a safety hazard and also does not allow for the associated circuits to be evaluated. The garage ceiling is subject. Have a licensed electrician evaluate the missing fixture circuits and install fixtures or cover for safety

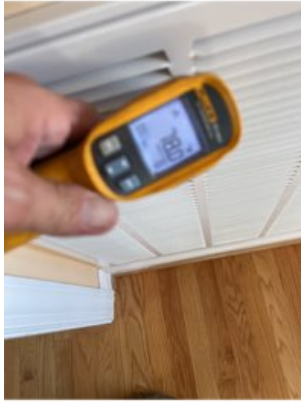
FIRST FLOOR RETURN AIR

2.2. There is an low temperature differential between incoming air temperature and outgoing air temperature in the first floor cooling/air conditioning system. Air temperature differential should be between 14° and 21°F. A low temperature differential is evidence the system is not cooling correctly and may have a refrigerant leak to the sealed system. Have an HVAC contractor further evaluate the system to include exterior unit, thermostat, interior unit and ducting to determine the cause and corrections/ repairs to the system are recommended.

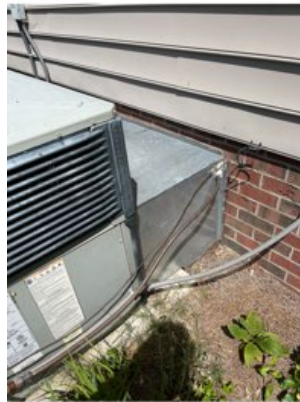
2.3. The condenser coils were found damaged, blocked, and dirty or clogged with debris. This will prevent this system from cooling adequately.

CONDENSER FINS CLOGGED

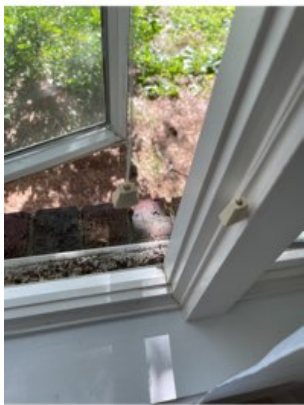
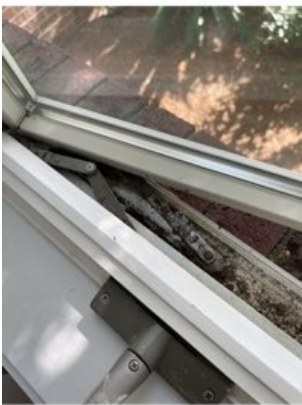
1.4. The windows in this home are aged. All materials and components have a life expectancy.
Multiple window deficiencies were discovered during the inspection.
Decay at sashes or the beginning of this, mostly second floor
Casements in the master bedroom and dining room that do not function as intended, will not close, latch or lock/ have damaged lower operators
abnormal oxidation at the window sills suggesting moisture intrusion.
Delamination of the **vinyl** wrap exposing the substrate
The above list are examples but not limited to. Due to the age of the windows and operating characteristics it is an observation that these windows may be at the end of their expected service life. The windows as inspected have evidence that parts are in a failure mode and or have several found deficiencies that suggest the life expectancy is up, when in use/ operated are prone to more parts breakage etc..... It is our recommendation that the client understand the scope of this / costs' etc.... as replacement of the windows is nearing and is inevitable. It is recommended a window and door installer further evaluate all windows to determine corrective measures, repair or replace.

CASEMENT TRACKS AND OPERATOR REQUIRES
CLEANING

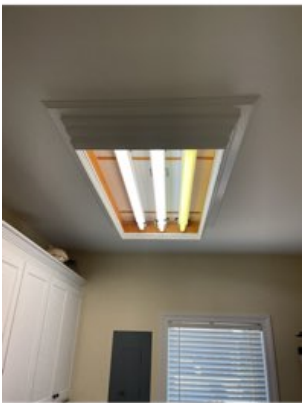
LAUNDRY ROOM LIGHT MISSING PRISMATIC
LENS

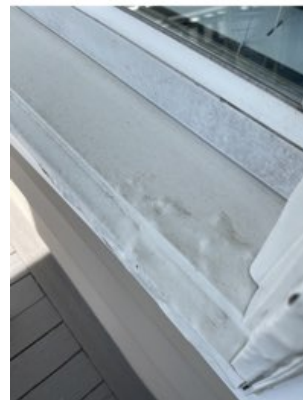
1.3. The wood window sashes have visible evidence of deterioration in the form of water staining and soft wood at the interior sashes and styles
The windows have some deterioration at the bottom of the lower sash where it contacts the window sill. These windows are in a condition of "functional" but beginning to deteriorate. The cause is unknown however suggests water intrusion. Recommend a window contractor further evaluate this discovery and determine what corrections can be done/ repairs, what the remaining life expectancy is and makes repairs or replace to ensure the home is weather tight. Without corrections further moisture infiltration can lead to component failure and inoperable windows.

WINDOW SILLS

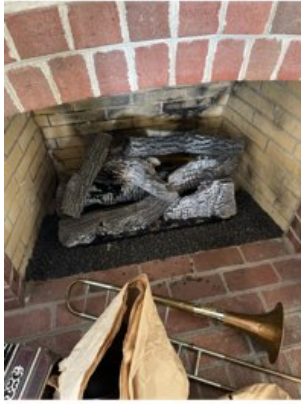
DAMPER NOT FUNCTIONAL

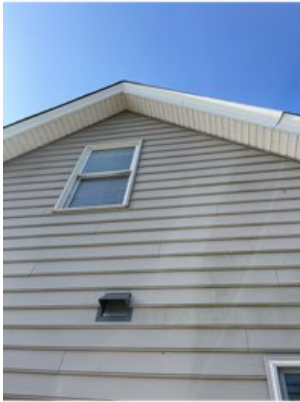
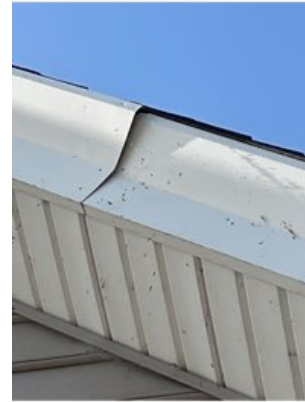
1.9. There are areas around the exterior soffit,s, fascia,s, window and door,s and their associated components that the metal/ composite trim /covering are loose, gapped or are not weather tight.

LOOSE RAKE TRIM, RIGHT SIDE

It is recommended that a siding contractor further evaluate the exterior trim work by removing areas suspect and make adjustments, repairs and corrections to secure the exterior of the home remains weather tight.

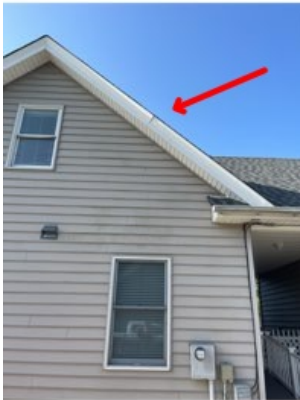
TRIM

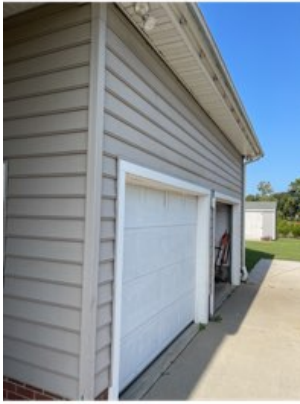
DAMAGED TRIM, LOWER GARAGE DOORS

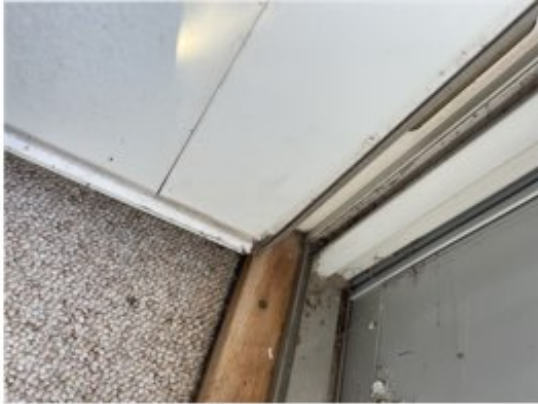
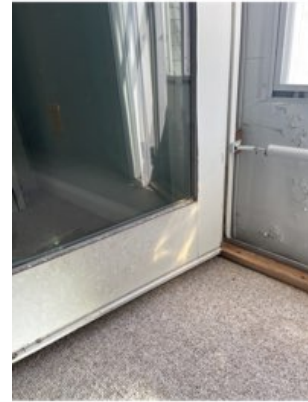
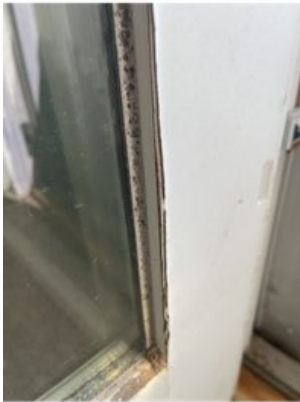
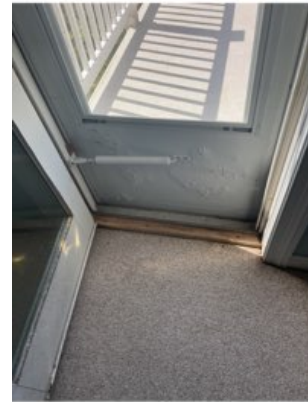
1.8. The exterior entry doors located at the second floor office, left, second floor bedroom, right, second floor back movie room slider, back of garage at storage room, side garage are delaminating. Repair and/or replace to secure that the door operates, locks and seals.

The delamination allows moisture intrusion that leads to decay

SECOND FLOOR OFFICE DOOR DELAMINATION

A window/ door installer is recommended to evaluate all doors to determine repairs, replacement and life expectancy of all doors and windows

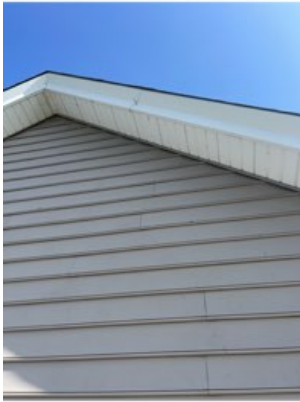
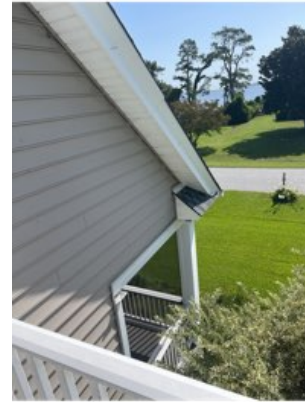
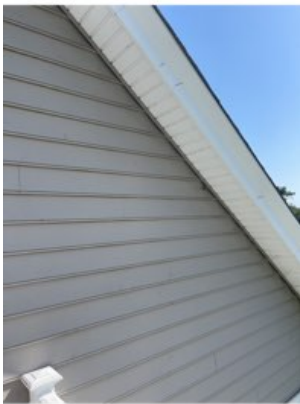
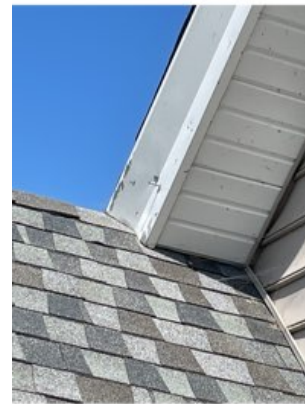
LOOSE TRIM
LEFT SIDE RAKES

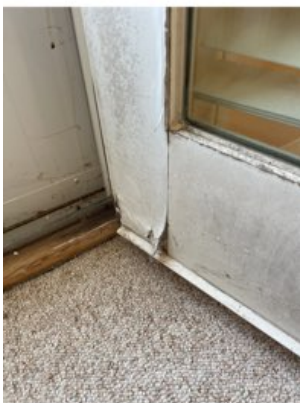
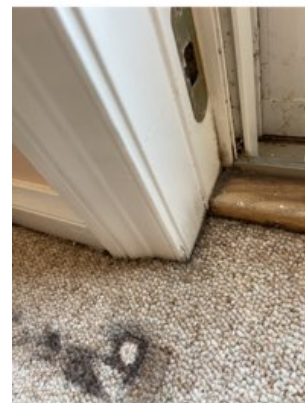
SECOND FLOOR BEDROOM DOOR TO
BALCONY

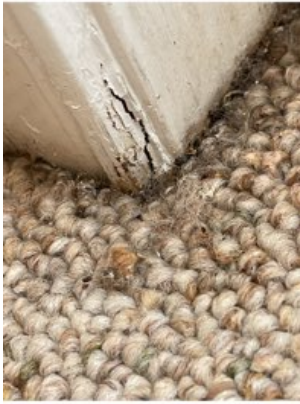
SECOND FLOOR BEDROOM DOOR TO
BALCONY

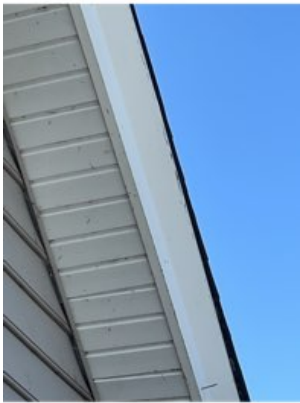
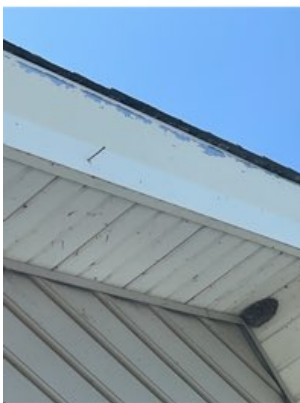
1.6. The PVC coated metal wrap used to cover the sub fascia's, rakes and associated trim systems has areas where the protective PVC surface treatment/ coating has adhesive failure.

The loss of the PVC coating suggests a manufacturers defect and can allow for pre mature deterioration from weather / corrosion which can lead to damage to the metal wrap which can eventually allow enough deterioration for water intrusion.

PVC ADHESIVE FAILURE

recommend a general contractor further evaluate this discovery and makes corrections/ replace the affected areas before this occurs.

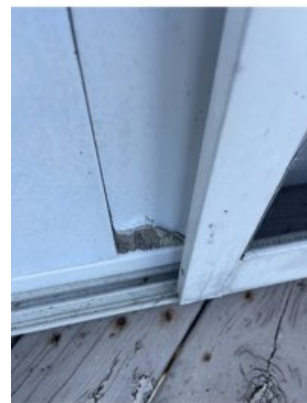
BACK SLIDER
DECK BALCONY

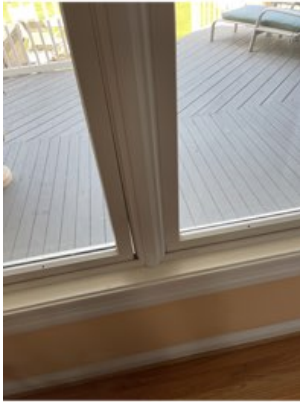
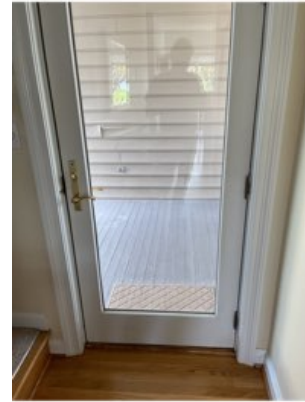
BACK FAMILY ROOM WINDOW GAPPED
DOES NOT SEAL

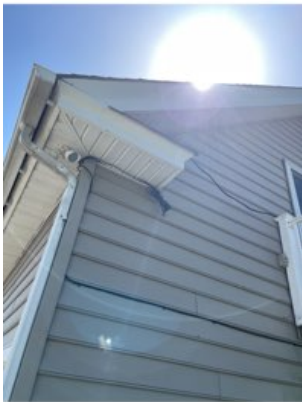
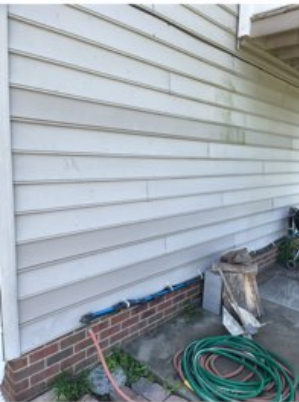
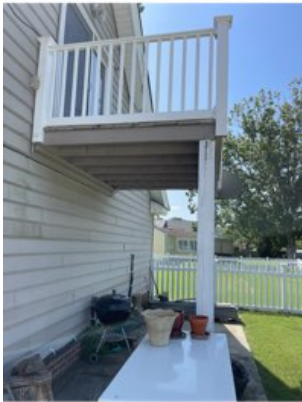
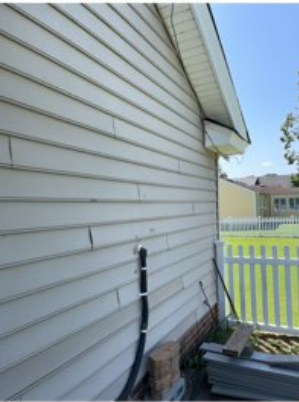
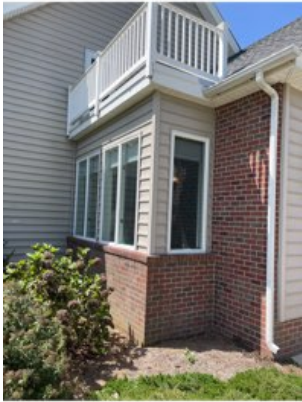
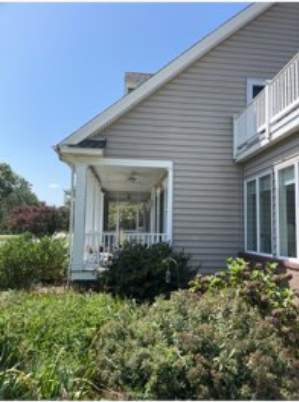
LOOSE TRIM

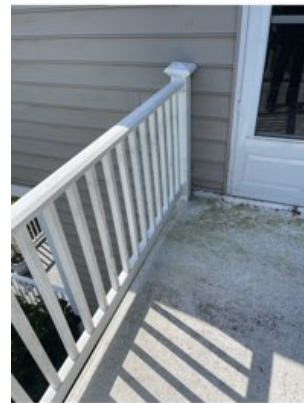
LOOSE RAILINGS

2.4. Safety issue noted due to inadequate railing attachment.

**Second floor office balcony and back elevated deck
safety concern, general contractor recommended.**

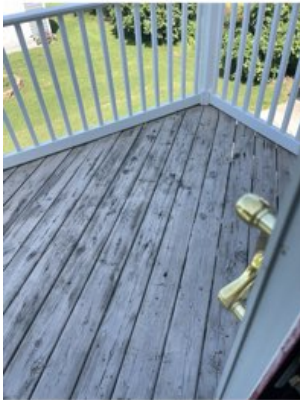
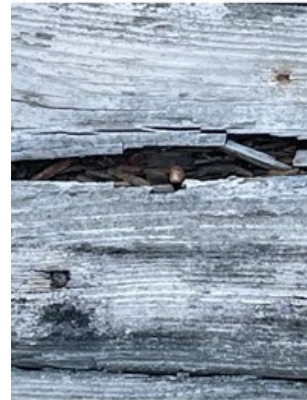
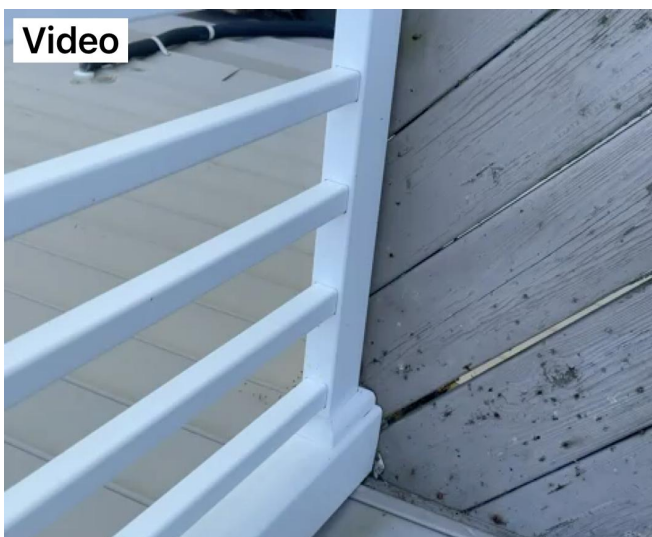
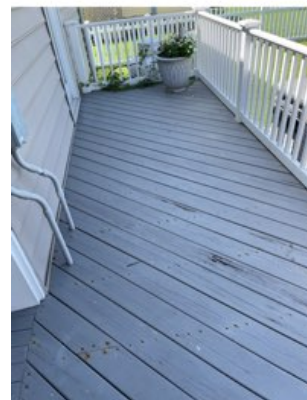
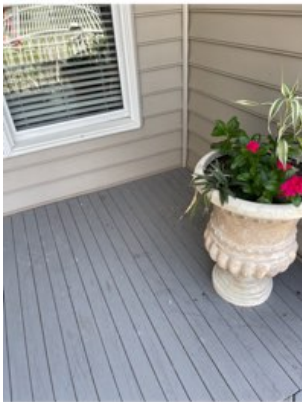
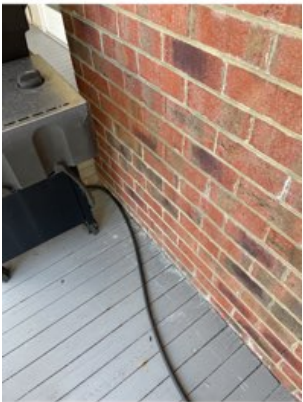
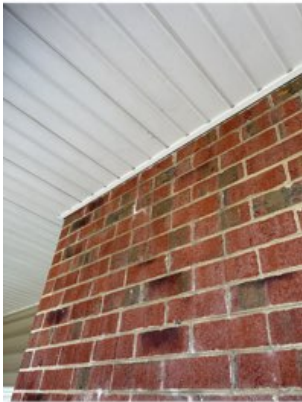
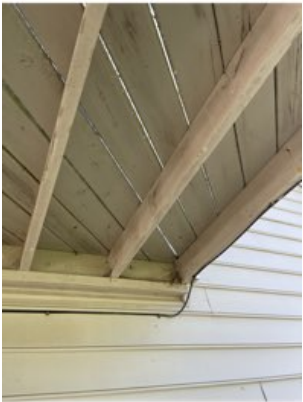
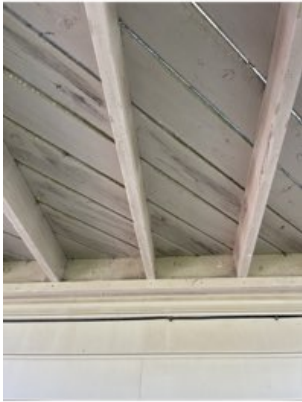
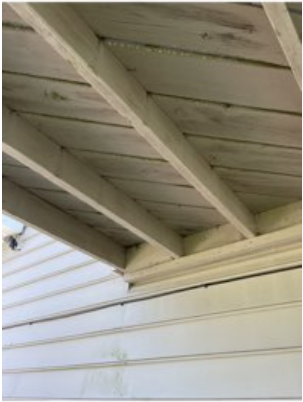
BACK ELEVATED DECK

2.5. : The deck (both back deck and elevated back deck (2 decks) inspection reveals obsolete structural connections, deterioration, decay, stair and railing deficiencies. This is a safety concern The deck surfaces and associated components should be further evaluated by a general contractor to determine the remaining life expectancy of the current deck and the scope of the repairs required to ensure the deck is current and safe.

Without corrections further deterioration can occur.

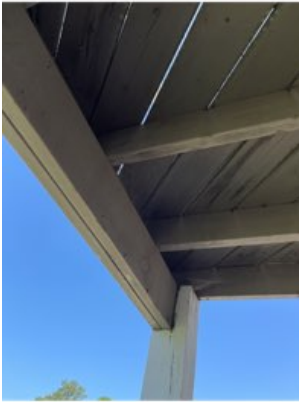
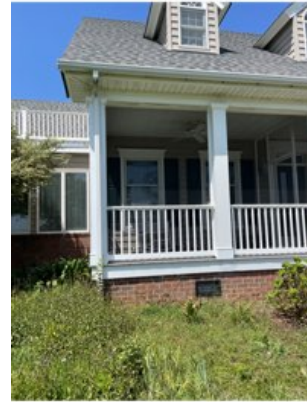
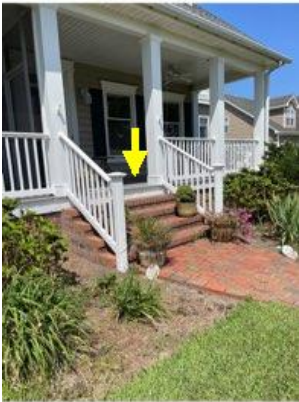
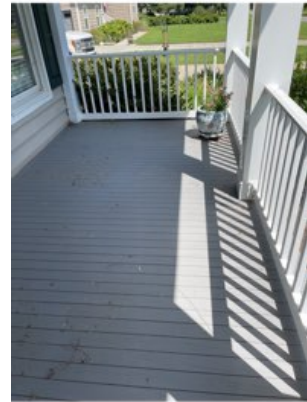
2.6. There is water damaged wood decking at the porch floor/decking surfaces, front at entry area and back at chimney. The water damage is the result of exposure and end grain wicking. Without corrections further deterioration will occur and may cause the decking to become unstable and a safety hazard. Wet water damaged wood is also an invitation for wood destroying insects. Replacement of affected deck components is recommended.

PORCH DECKING AGING

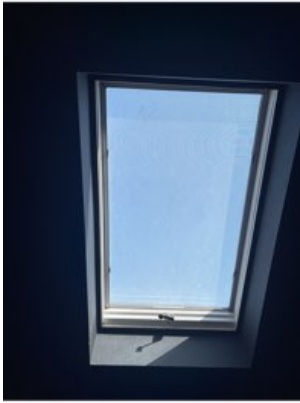
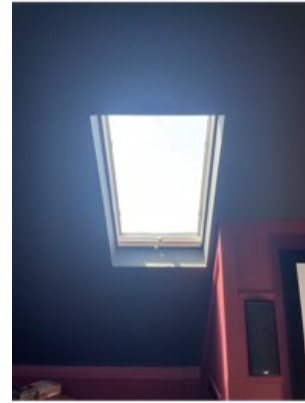
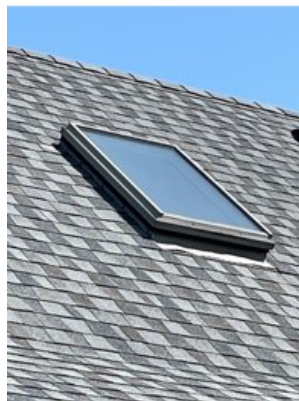
3.1. SKY LIGHTS NOT OPERATED

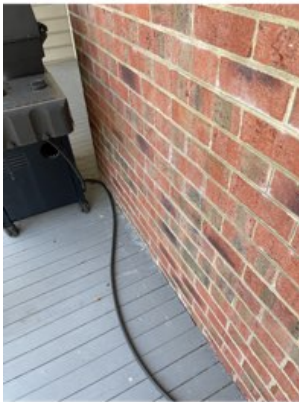
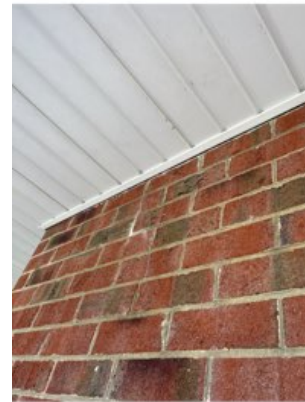
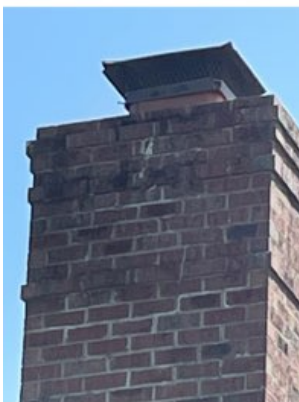
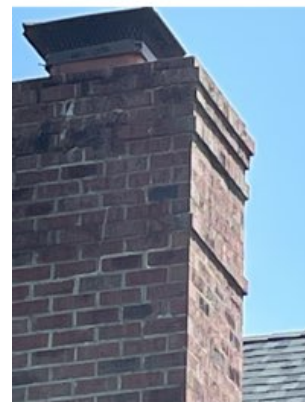
4.1. The mortar cap of this chimney, sometimes known as the 'crown', was found to be cracked, weather worn or damaged by exposure to weather, time and the corrosive effects of moss. When this occurs, water seeping past the crack can cause substantial damage to the masonry stack, as well as to the framing, walls and ceilings below. Having this stack and cap further evaluated/ repaired by a chimney mason or certified sweep is recommended. without corrections further water penetration can occur and lead to further deterioration of the fire box, chimney and any associated components in contact with the chimney

VEGETATION / MOSS GROWTH CHIMNEY

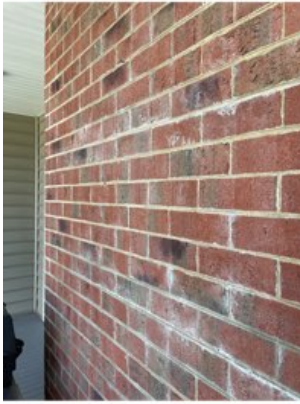
2.11. Efflorescence was visible on the masonry chimney wall. This is a indication of historical water intrusion or a water source and path that can lead to structural deterioration and damage. It is recommended that this discovery be further evaluated by a general contractor to determine the source, affect or condition of the CMU foundation wall below the chimney, the chimney, the framing around the chimney and associated wall cavities and corrective measures. Without corrections this condition can lead to further deterioration and movement

CHIMNEY EFFLORVESENCE

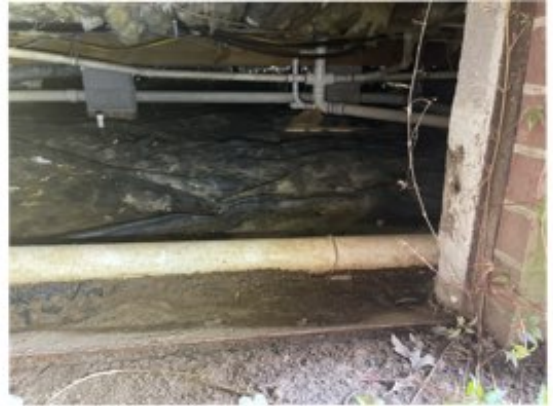
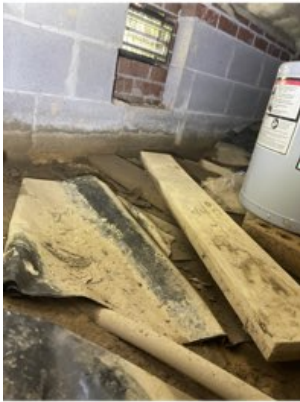
DEBRIS

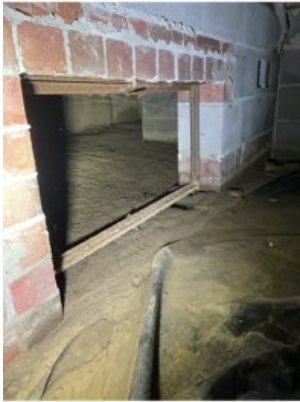
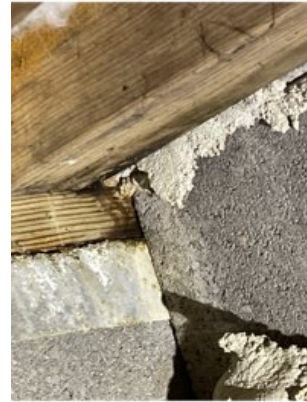
CHIMNEY FRAMING MOISTURE INFILTRATION

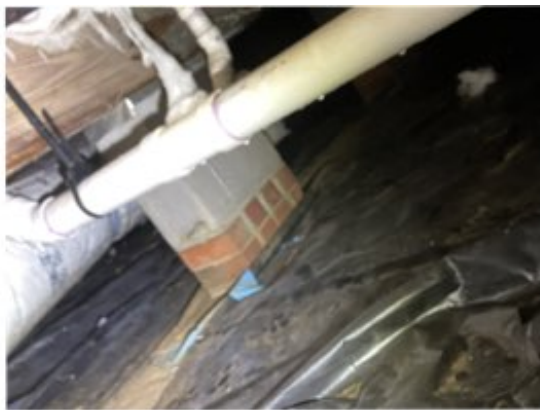
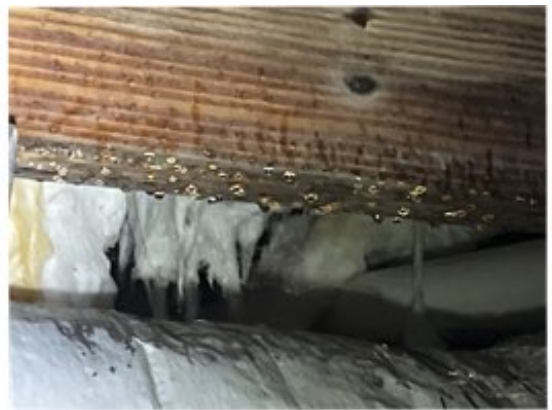
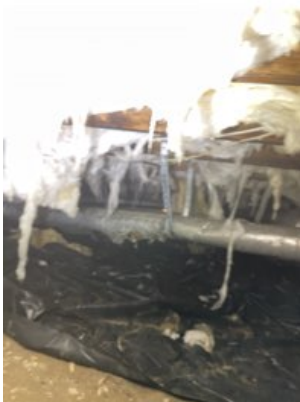
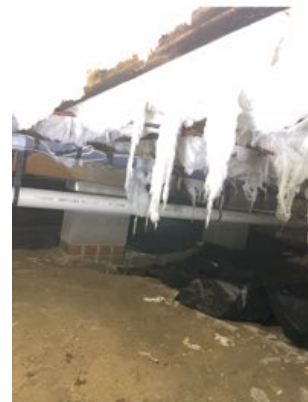
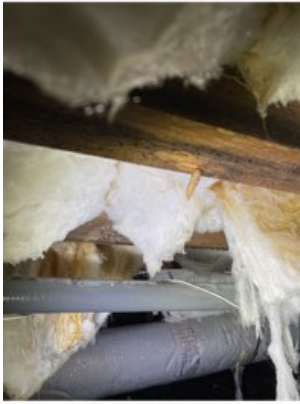
STREAMING INSULATION, SATURATED

A moisture control contractor can further evaluate this discovery to determine corrective measures. Without corrections further decay and damage is possible.

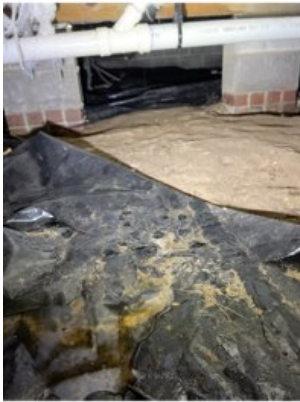
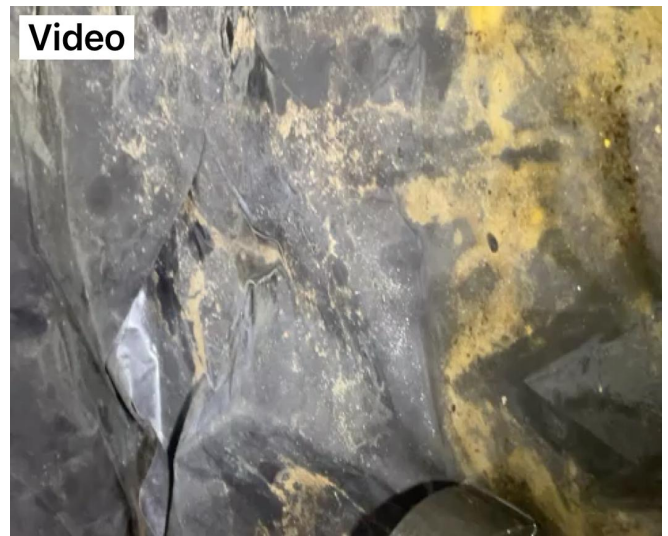
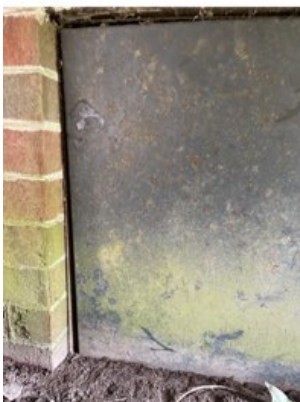
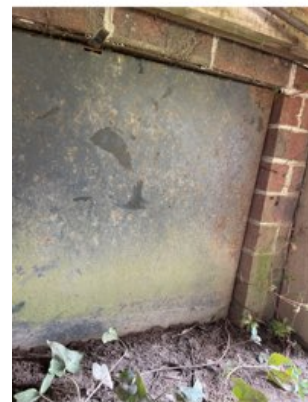
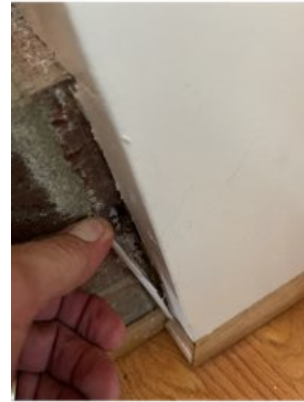
PROBING REVEALS DETERIORATION IN AREAS

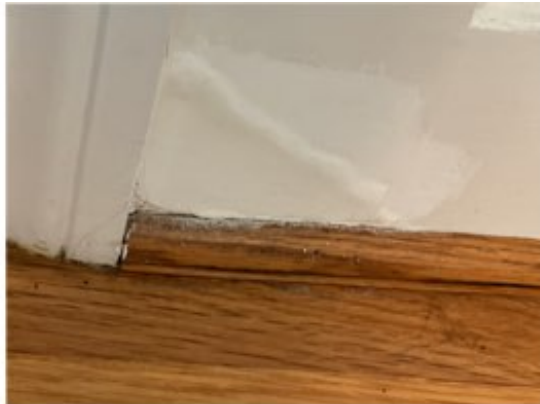
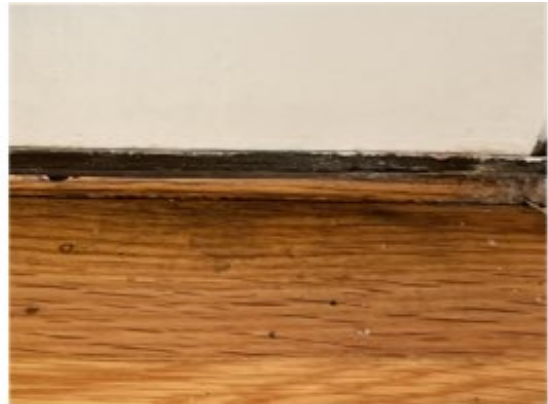
FRONT DOOR, MOISTURE PENETRATION, NOT ACCESSIBLE FROM CRAWL DUE TO WET CONDITIONS

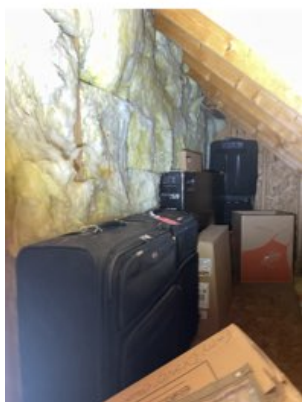
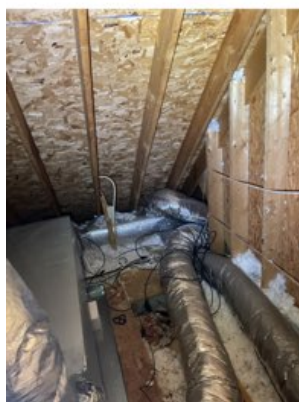
3.2. There are old water stains in the attic at the sheathing and/or framing components. These stains are evidence of past leaks. At the time of the inspection there was no indication of current leaking and/or structural damage from the past water intrusion. Roof coverings, and their associated flashings, when aged will deteriorate and/or can become mechanically damaged from storms, tree limbs or other circumstances, and, as with all systems in the home require routine monitoring and maintenance.

STAINS DRY, BACK KNEE WALL

Recommendation:Roofing Contractor

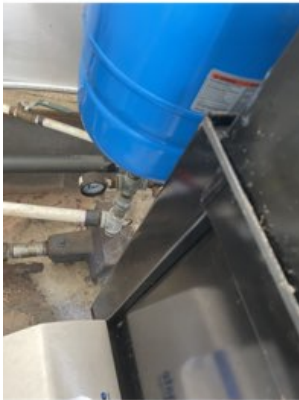
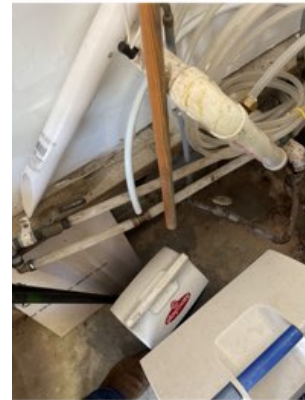
1.3. This home has a plumbing supply system that uses polybutylene plastic distribution lines and compression band fittings.

Due to the nature of this latent defect, it was not possible to adequately assess the condition of the plumbing system during the home inspection. A licensed plumbing contractor should be consulted for a complete evaluation of the plumbing system to determine the significance of this concern.

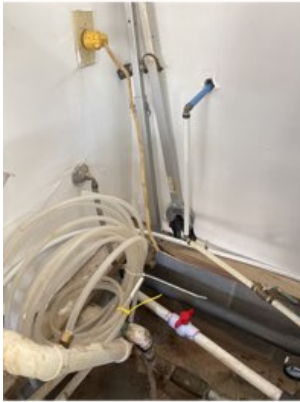
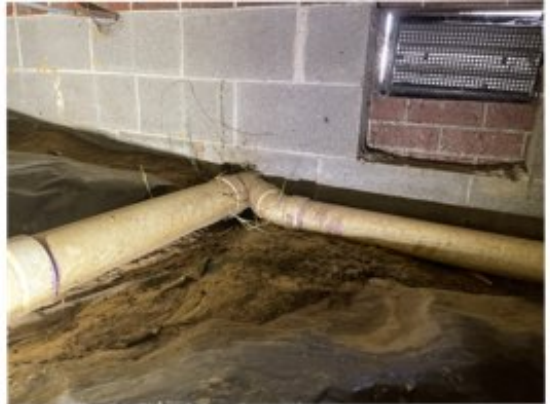
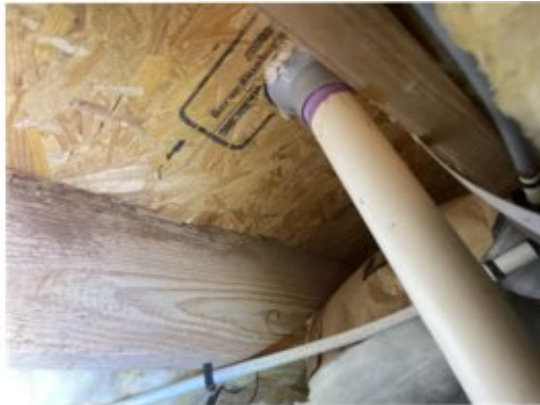
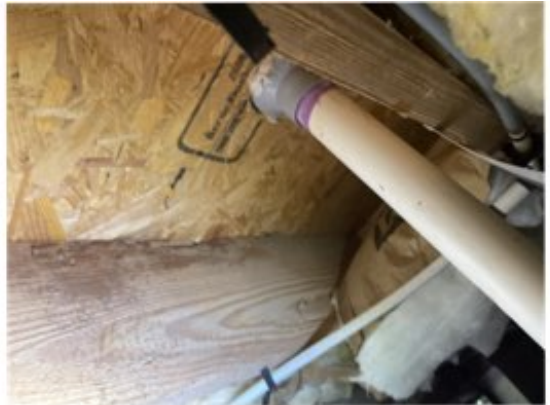
SHOWER DRAIN SUB FLOOR

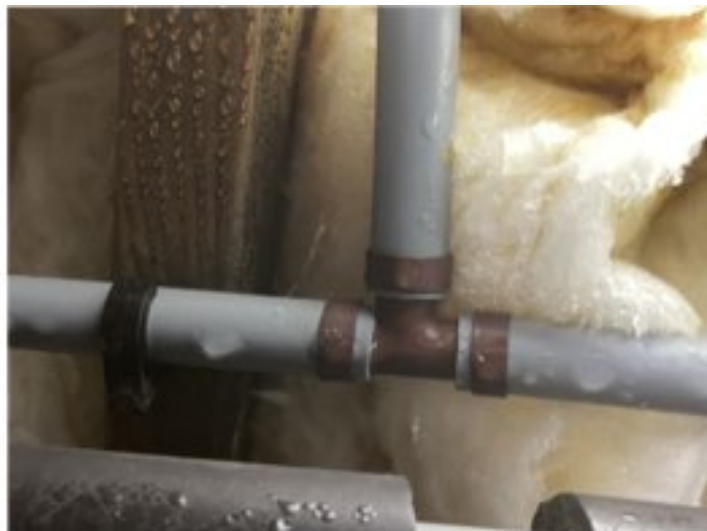
it is no longer an approved plumbing system due to a history of material failures. The failures were related to improper installation, improper handling, improper storage, and plastic deterioration due to chemical reactions with the water supply. Due to the nature of this latent defect, it was not possible to adequately assess the condition of the plumbing system during the home inspection. A licensed plumbing contractor should be consulted for a complete evaluation of the plumbing system to determine the significance of this concern.

PB PIPE
