Elite Home Inspections

127 E ANYWHERE DRIVE, SOMEWHERE, NC 12345

Inspection prepared for: REPORT SAMPLE

Date of Inspection: 1/1/2021 Time: 9:00 AM

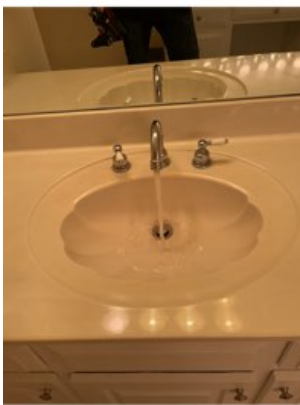
2.2. There is a leaking faucet handle/s located in the second floor back bath sink that need correction. The leaks are observed during the function/operation of the faucets. Without corrections the leaks can infiltrate into the sink base and cause water damage. Have a licensed plumber evaluate and make corrections

SECOND FLOOR BACK BATHROOM SINK RIGHT
SIDE VALVE LEAKS

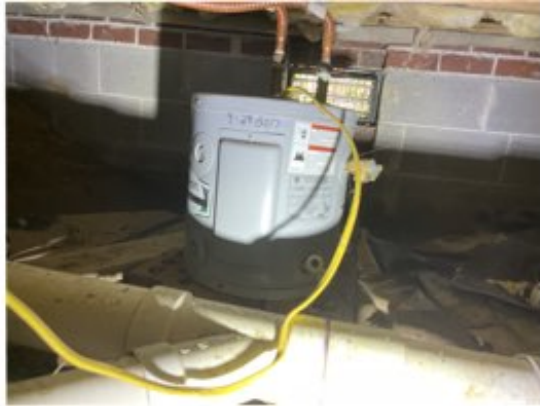
4.1. The water heater is located in the crawl space. This location is subject to high humidity, possible water intrusion as well as unconditioned space. The unit is sitting in damp conditions with no approved dedicated stand

Due to location our concern is electrical components in high humidity environment causing corrosion, possibly flooding causing multiple problems and freeze/thaw etc.....

WATER HEATER IN CRAWL

We recommend a licensed plumber further evaluate this installation and determine if the location is an approved location by the appliance manufacturer and local code requirements.

Have this evaluated by a licensed plumber and confirm if the appliance is approved for this location and or make corrections.

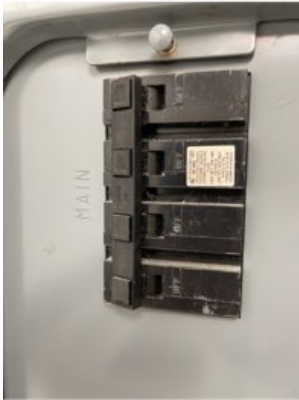
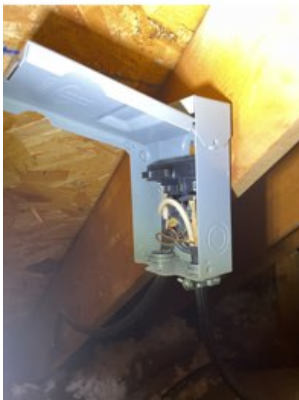
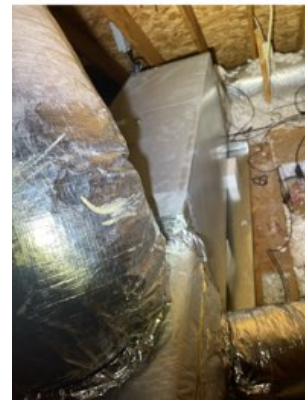
Location: Attic

2.1. : The service disconnect that is missing the protective cover that isolates the electrical conductors and lugs from contact.

The subject disconnect box is missing this interior cover and is therefore a contact hazard and potentially can cause harm if contact is made. As well as is exposed to the weather which can lead to corrosion and or pest damage

ATTIC HVAC DISCONNECT MISSING COVER

Recommendation: Licensed Electrician

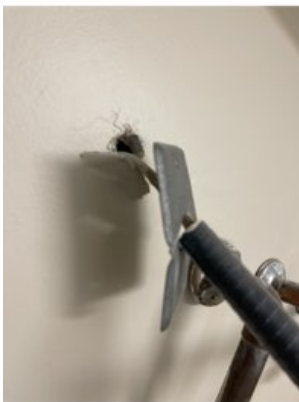
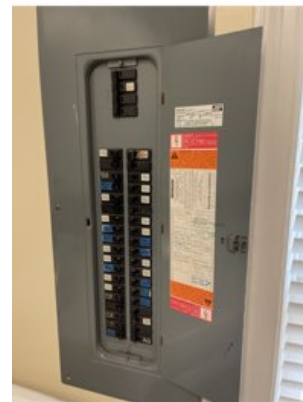
3.2. : There is wiring entering the wall at the water heater service that is short in conduit coverage and that does not have approved strain relief bushings. Wiring that enters the any enclosure, box or cabinet is supposed to be solidly anchored and protected where it enters the enclosure/ device by a bushing so the sharp edges of the enclosure/ box does not cut into the wiring and cause a short which is a safety hazard. We recommend having a licensed electrician correct all un-bushed cables described.

WATER HEATER SERVICE, LUANDRY ROOM
WALL

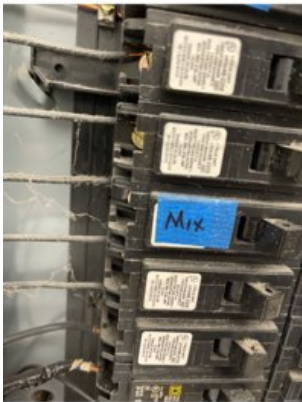
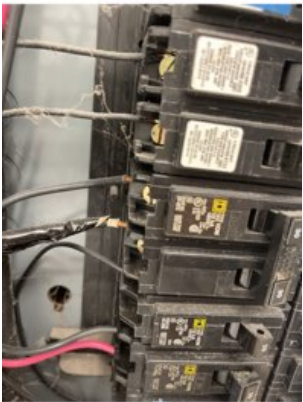
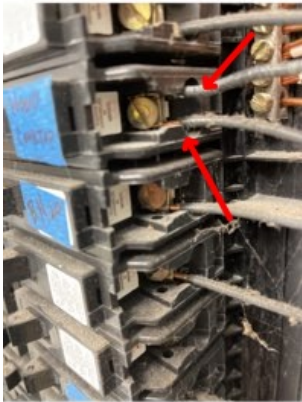
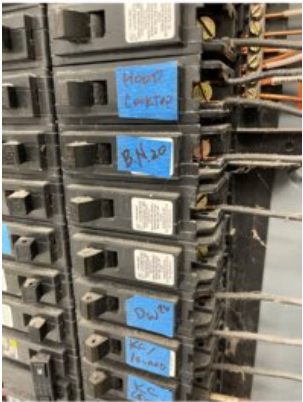
3.1. Double lugged breaker/s inside the service entrance panel was discovered. ONE, right side, pictured. Double lugging is where more than one branch circuit is connected to a single circuit breaker. Most breakers are not designed to accommodate more than one circuit. A licensed electrician should further evaluate this discovery to determine if this application is approved and it's combined load meets the circuit requirements. Without corrections the physical connection of the subject breaker is compromised which can lead to excessive heat and breaker damage. This is a safety discovery, therefore evaluation and correction by a licensed electrician is strongly recommended.

DOUBLE TAP ON BREAKER MARKED HOOD
COOK TOP

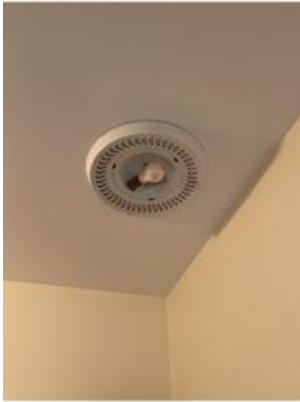
MASTER CLOSET LIGHT OUT

Therefore we believe that the named fixtures should be further evaluated, bulbs installed, replaced and or further evaluated by an electrician to determine the cause for no illumination.

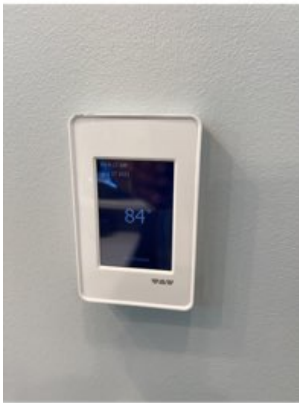
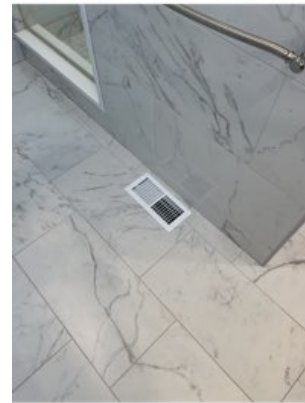
SUPPLIMENTAL FLOOR HEAT, NOT TESTED

Therefore while the heat system was reported on and visually inspected, the unit was not operated. A professional HVAC contractor should be contacted to further evaluate the heating system and run this system.

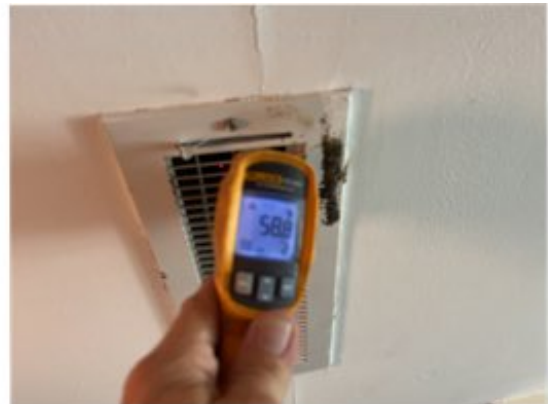
SECOND FLOOR REGISTER SUPPLY AIR TEMP

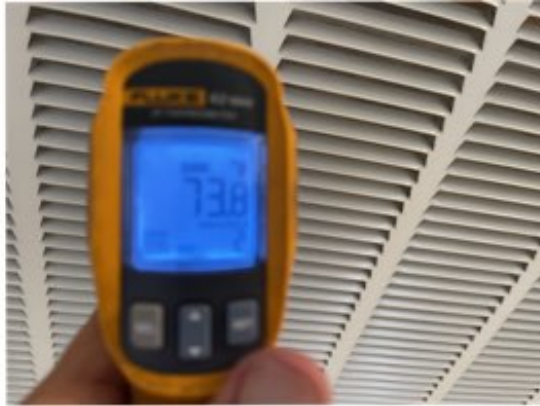
SECOND FLOOR RETURN REGISTER AIR TEMP

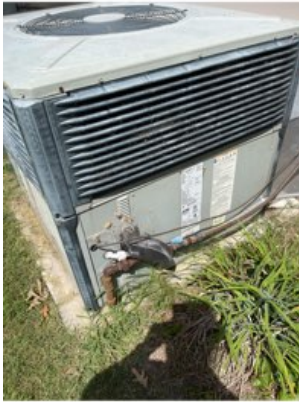
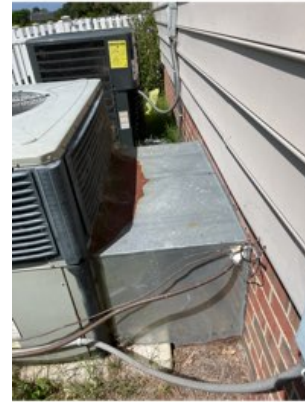
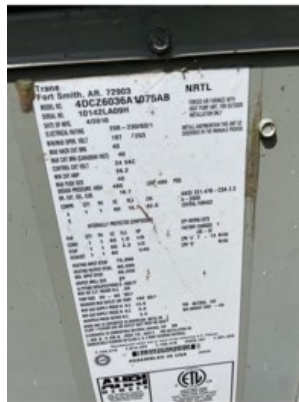
OLDER UNIT, FIRST FLOOR GAS PAC

2.1. Air conditioners have a life expectancy (statistical) of 8 to 12 years. Operation of the system will be noted in this report. However, it's statistical life expectancy is up. It is recommended that this system be serviced and qualified due to its age.

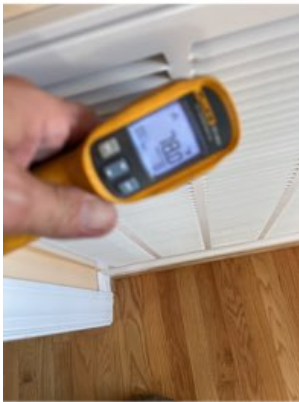
2.2. There is an low temperature differential between incoming air temperature and outgoing air temperature in the first floor cooling/air conditioning system. Air temperature differential should be between 14° and 21°F. A low temperature differential is evidence the system is not cooling correctly and may have a refrigerant leak to the sealed system. Have an HVAC contractor further evaluate the system to include exterior unit, thermostat, interior unit and ducting to determine the cause and corrections/ repairs to the system are recommended.

FIRST FLOOR RETURN AIR

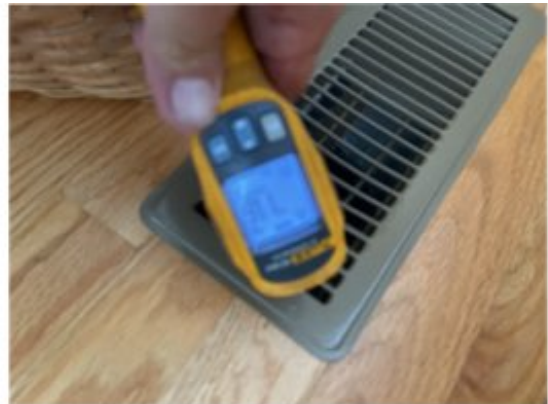
FIRST FLOOR REGISTER AIR

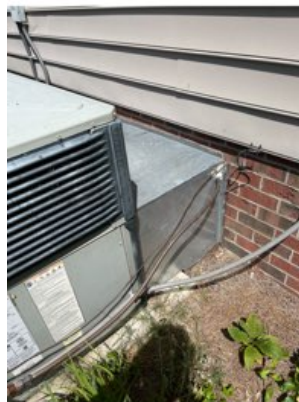
2.3. The condenser coils were found damaged, blocked, and dirty or clogged with debris. This will prevent this system from cooling adequately.

CONDENSER FINS CLOGGED

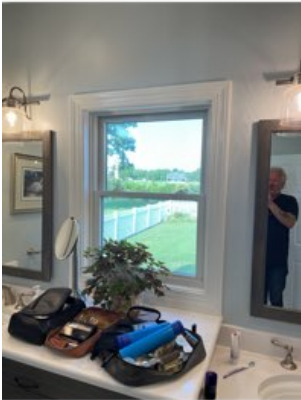
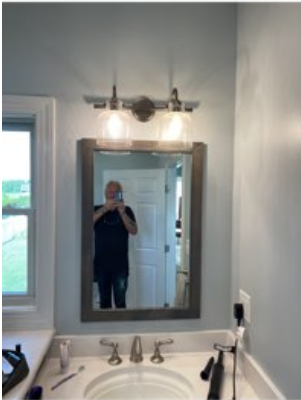
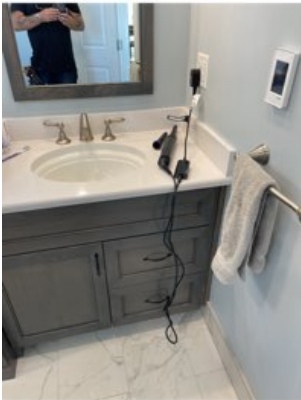
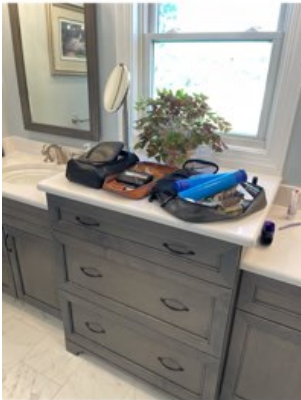
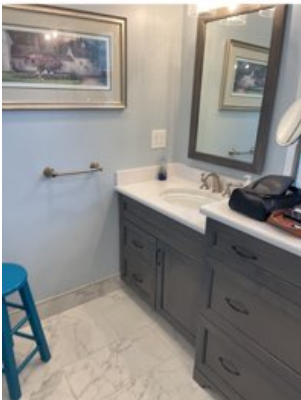
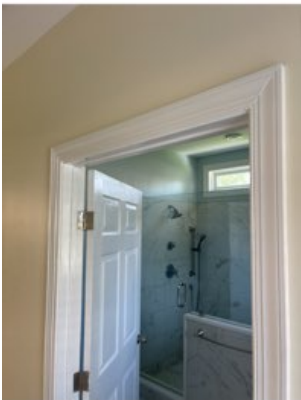
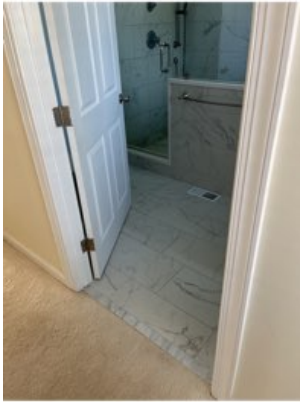
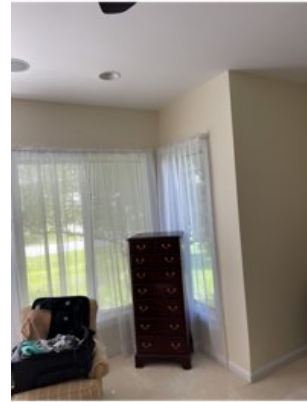
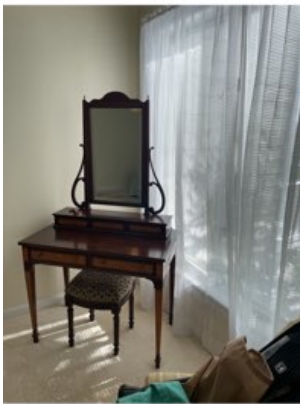
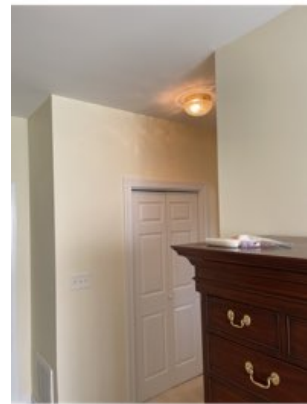
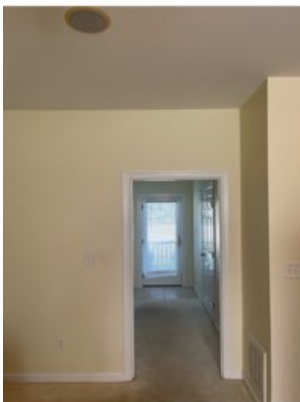
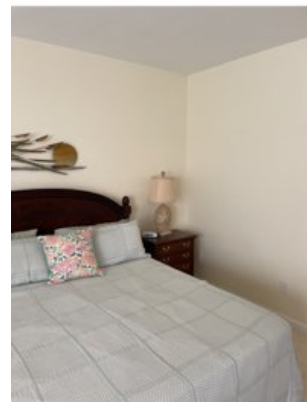
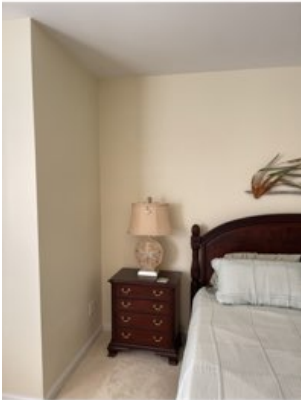
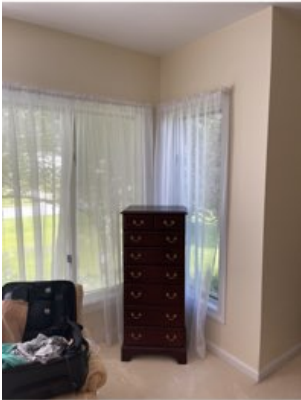
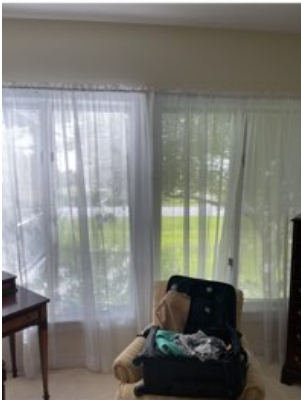
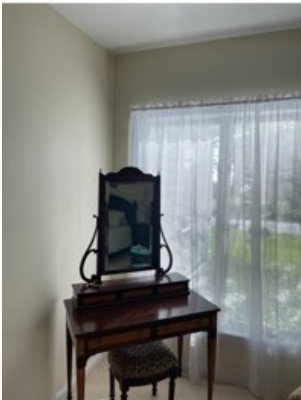
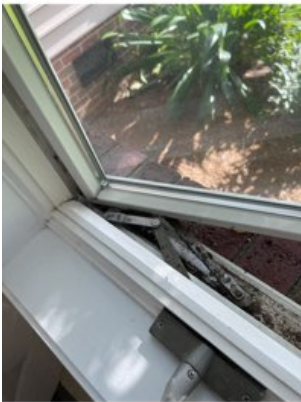
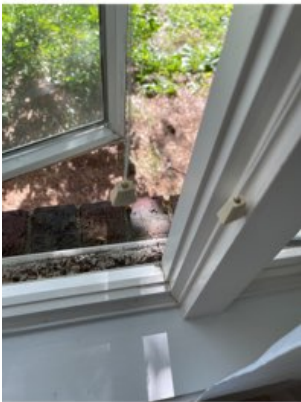
1.3. The wood window sashes have visible evidence of deterioration in the form of water staining and soft wood at the interior sashes and styles

The windows have some deterioration at the bottom of the lower sash where it contacts the window sill.

These windows are in a condition of "functional" but beginning to deteriorate. The cause is unknown however suggests water intrusion. Recommend a window contractor further evaluate this discovery and determine what corrections can be done/ repairs, what the remaining life expectancy is and makes repairs or replace to ensure the home is weather tight.

Without corrections further moisture infiltration can lead to component failure and inoperable windows.

Multiple window deficiencies were discovered during the inspection.

Decay at sashes or the beginning of this, mostly second floor

abnormal oxidation at the window sills suggesting moisture intrusion.

The above list are examples but not limited to. Due to the age of the windows and operating characteristics it is an observation that these windows may be at the end of their expected service life. The windows as inspected have evidence that parts are in a failure mode and or have several found deficiencies that suggest the life expectancy is up, when in use/ operated are prone to more parts breakage etc..... It is our recommendation that the client understand the scope of this / costs' etc.... as replacement of the windows is nearing and is inevitable.

It is recommended a window and door installer further evaluate all windows to determine corrective measures, repair or replace.

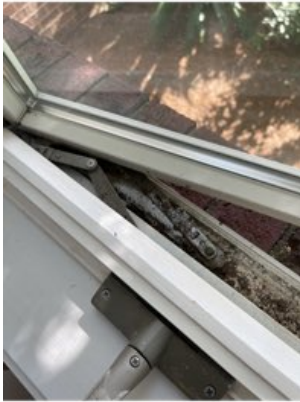
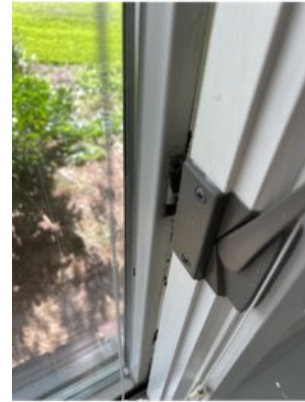
CASEMENT TRACKS AND OPERATOR REQUIRES
CLEANING

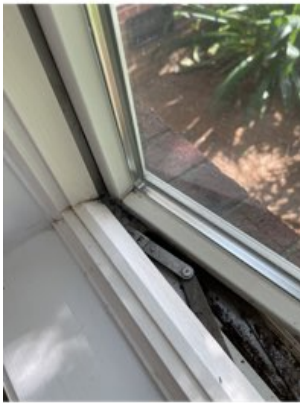
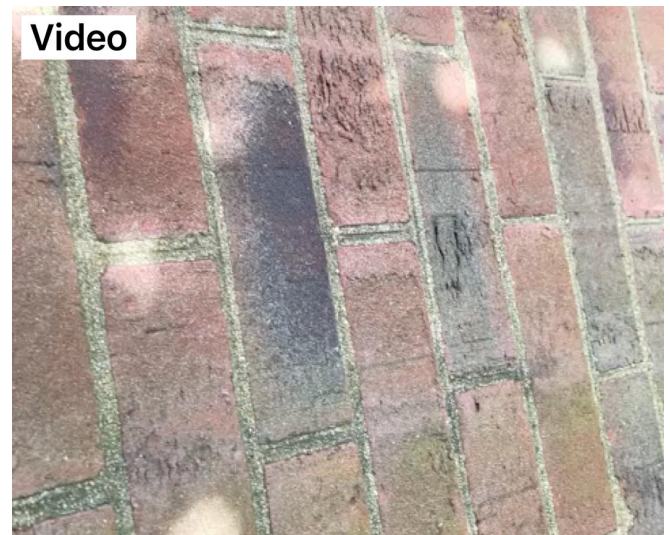
Casements in the master bedroom and dining room that do not function as intended, will not close, latch or lock/ have damaged lower operators

CASEMENTS
MASTER BEDROOM
FIVE TOTAL

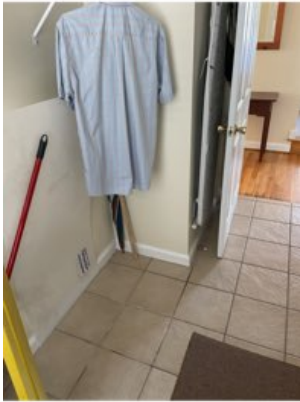
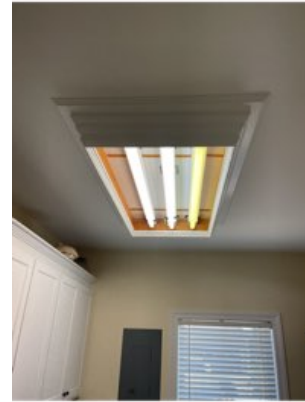
LAUNDRY ROOM LIGHT MISSING PRISMATIC LENS

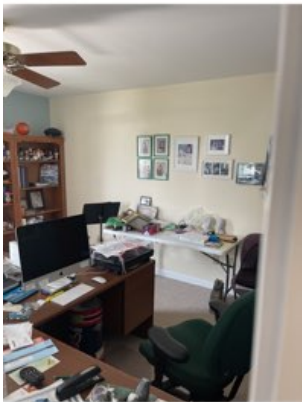
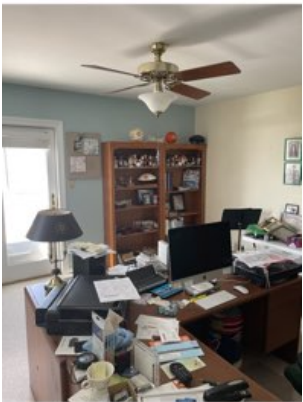
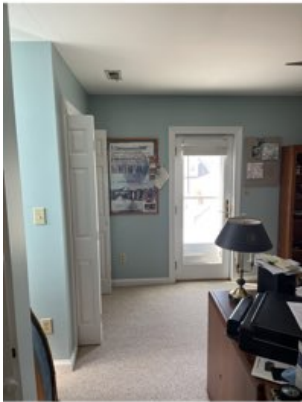
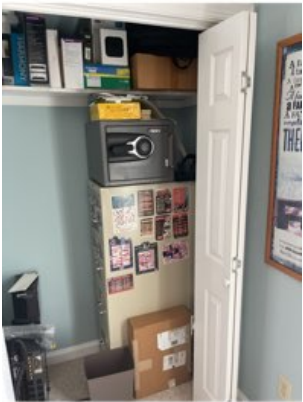
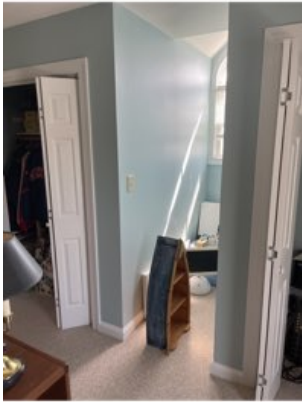
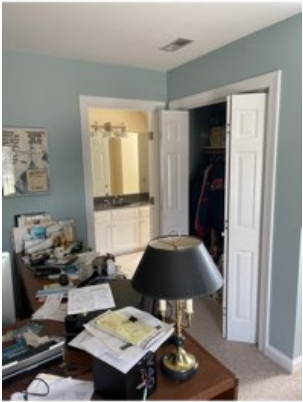
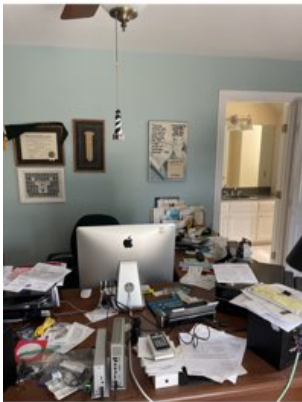
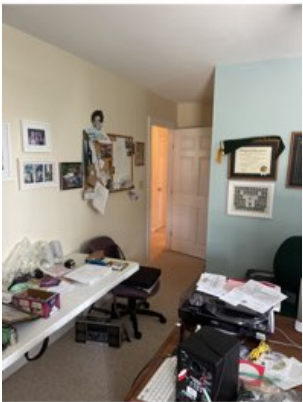
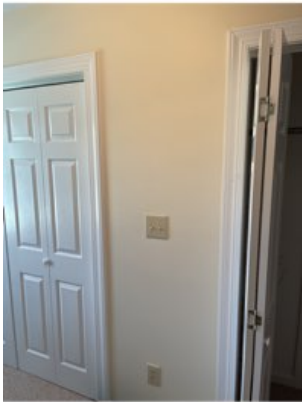
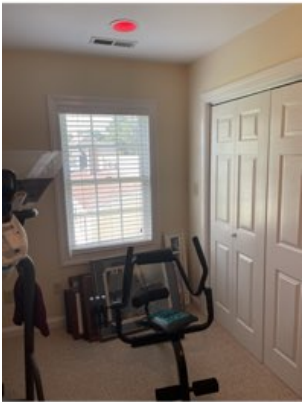
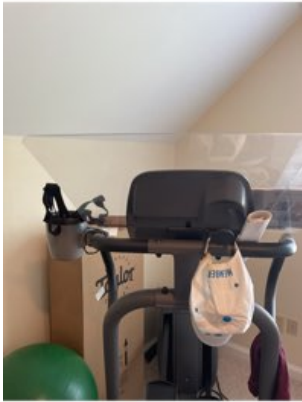
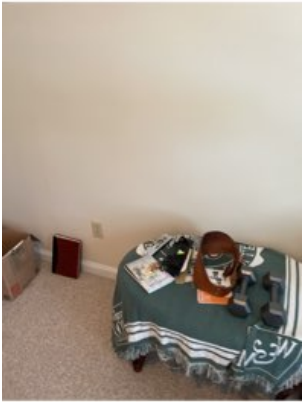
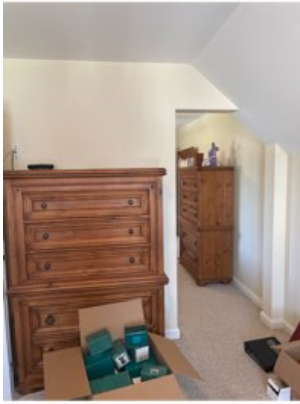
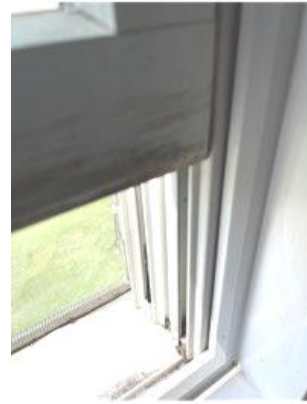
WINDOW DECAY

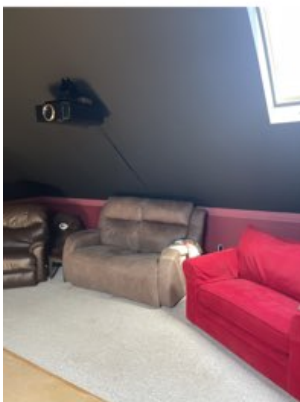
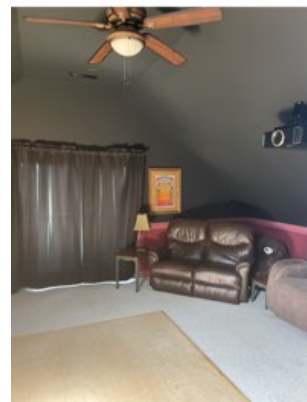
HANDLE MISSING

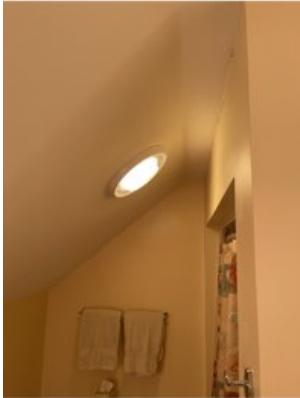
NOISY FAN

2.1. There is a noisy/vibrating exhaust device (fan) located in the second floor back and front bathroom

This may be an indication of failure and should be cleaned, serviced, repaired and/or replaced due to this.

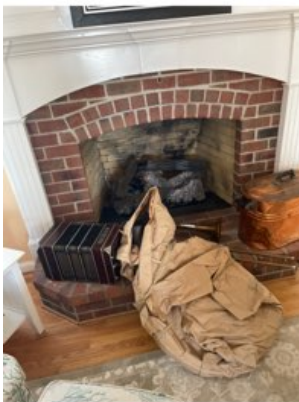
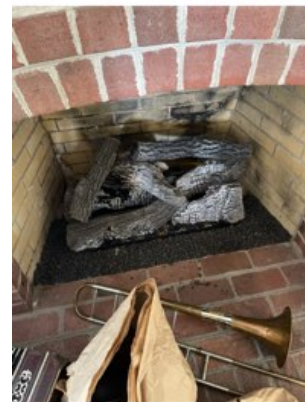
3.1. The main Gas Logs where found sooted. Heavy soot suggesting improper combustion as well as dust and lint where found covering the logs , burner and associated components. Have a gas log technician or a gas contractor further evaluate the instalation and clean the appliance and test for safety and operate to ensure function. without corrections the gas logs may off gas harmful fumes
